Department of Environmental Protection		GENERAL INSPECTION REPORT		Bureau of Land Recycling and Waste Management	
Type of Inspection	WM Identification Number	Entry Time/Date	Inspection ID		
Complaint response	Site ID: 865337	3/14/2024	3728358		
Facility/Incident Name and Location			Municipality		
Kingdom Provisions			Plumstead		
5960 Durham Road Pipersville PA 18947			County Bucks		
Name, Address of Responsible Official		Title			
Ephriam Stoltzfus –		Owner			
Kerry Rush – Owner Brent Pressley - Manager Amber Pressley - Manager		Telephone	Interviewed		
		215-767-8943	Yes <input checked="" type="checkbox"/> No <input type="checkbox"/>

Facility/Incident Name and Location	Municipality
Kingdom Provisions	Plumstead
5960 Durham Road Pipersville PA 18947	County
	Bucks

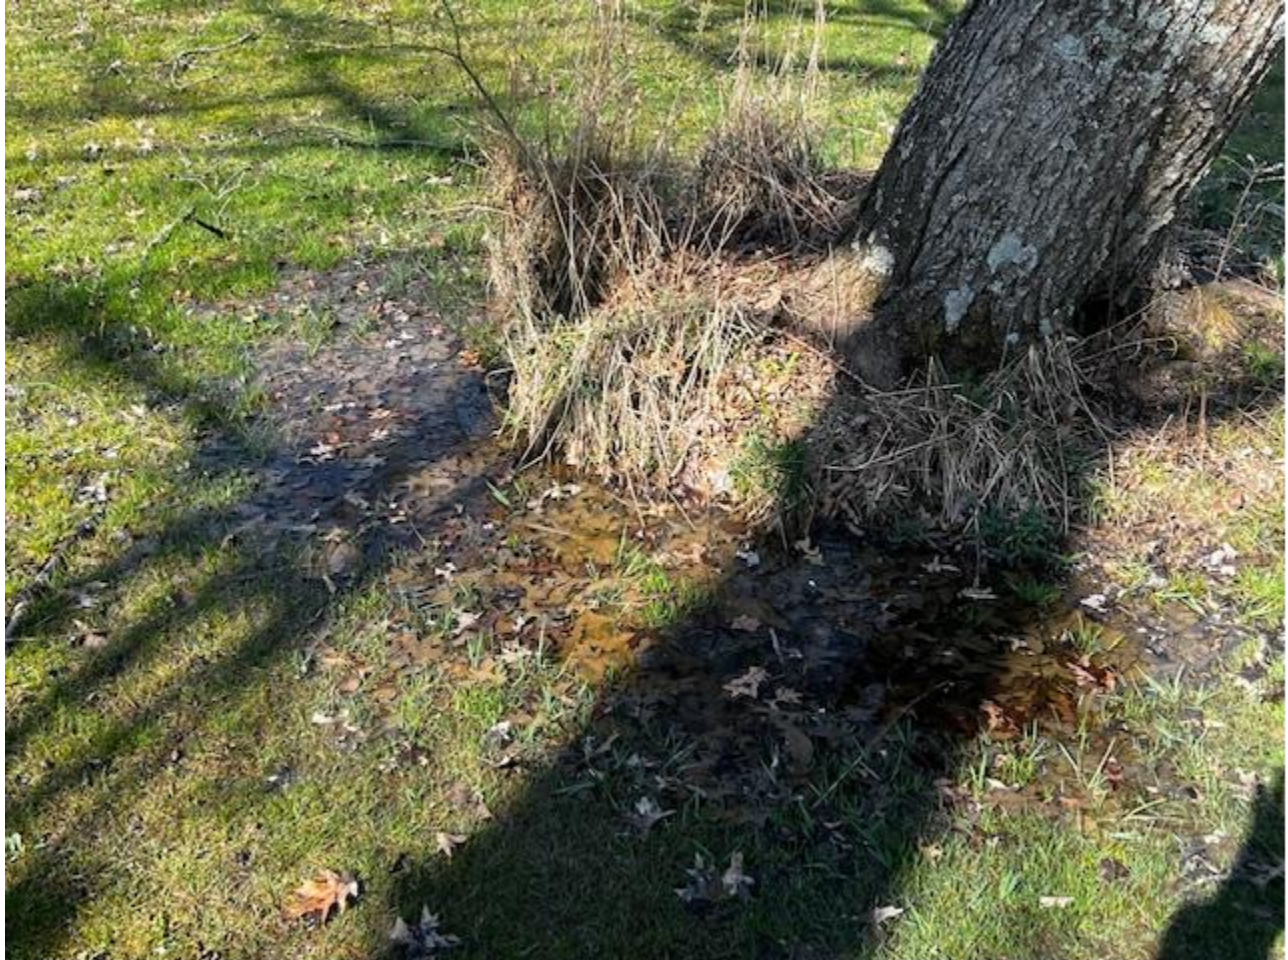
Observations were first made from the property located at 6030 Durham Road, the site where a release of FPR material was observed on March 5, 2024. Small area of pooling water or puddles were present, but no staining or red color was observed. Along the fence line separating the 6030 property from the KP property, on the KP side, an earthen berm is present. Adjacent to this berm some pooling water was occurring. That water did not appear, visually, to contain FPR material.

Image 1: Image taken at 6030 Durham Rd. displaying pooling storm water.
Taken by Jonathan Bower on 3/14/2024

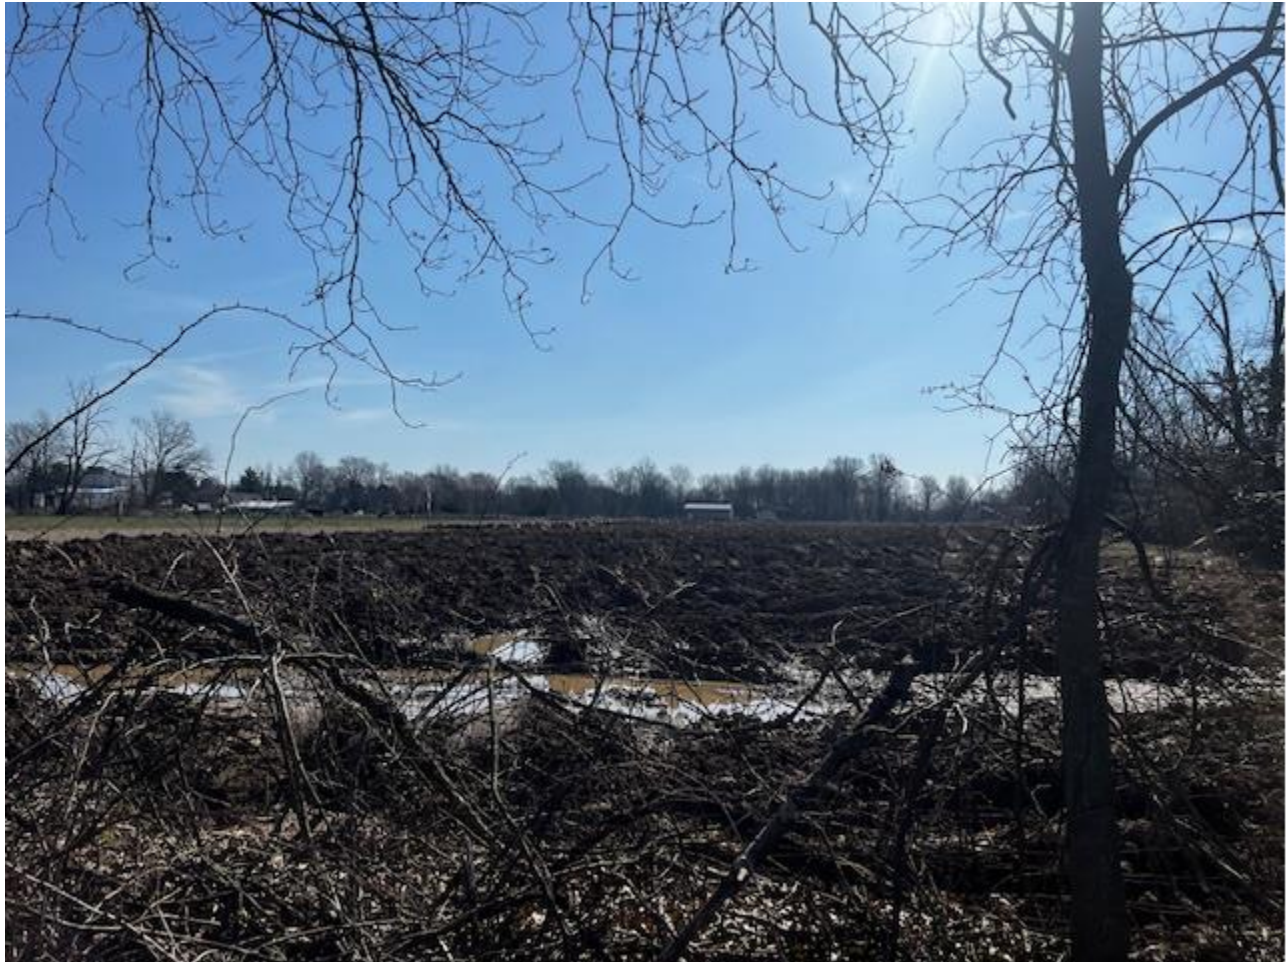
Image 2: Image taken at 6030 Durham Rd. at the fence line where a berm is present and storm water is pooling.

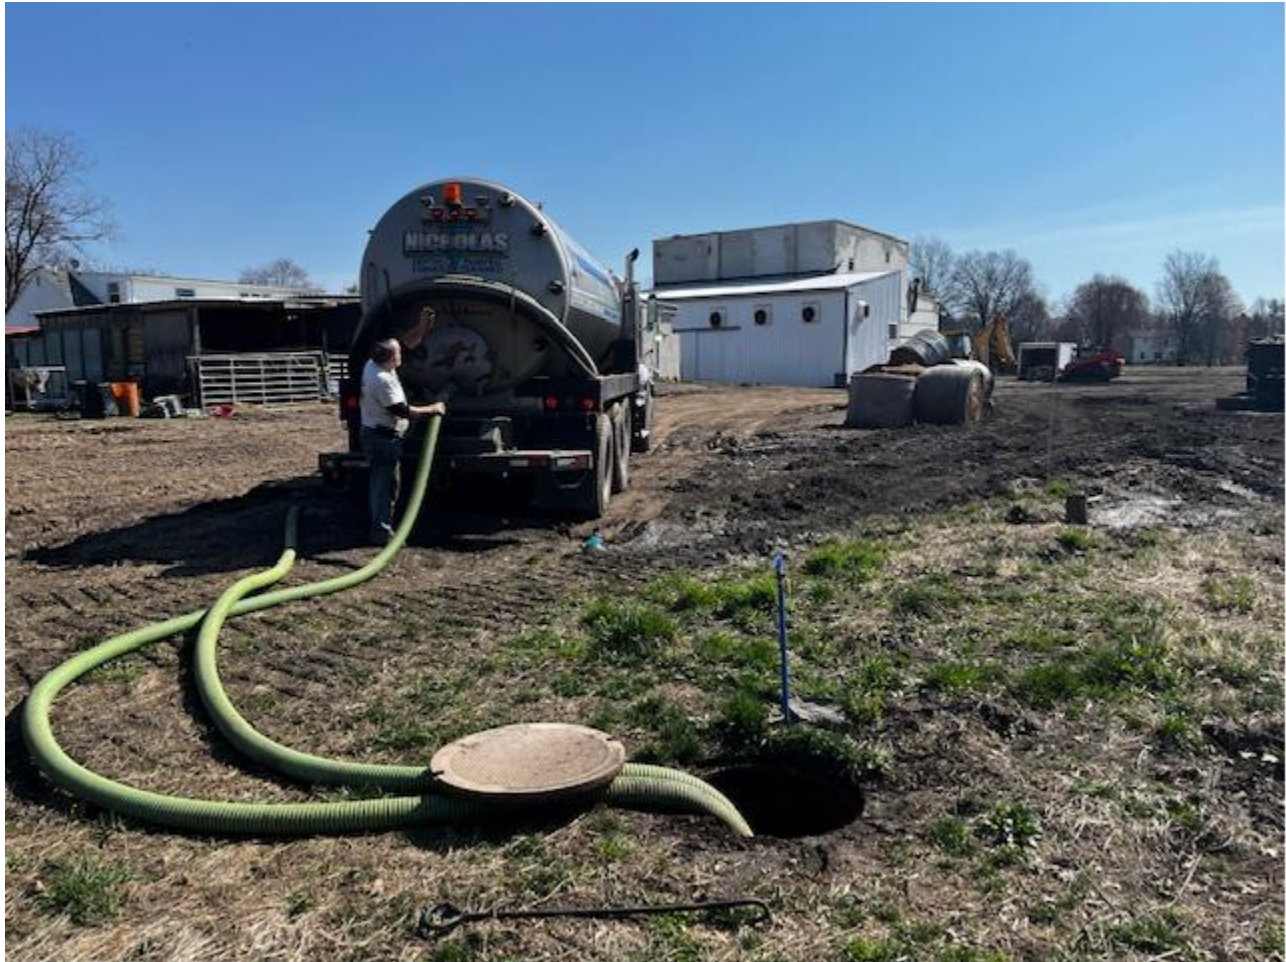
Next a complaint investigation was conducted at KP. Amber Presley, Manager, was present and available to discuss the land application of FPR. Previous to this inspection, KP had been working with the Department to provide information requested in response to the March 5, 2024, incident response. At the time of the inspection KP provided a copy of the manure management plan, as well as land application logs and disposal documentation for liquid waste. From the information provided it appears that KP has land applied 750 gallons on 4 occasions beginning March 1, 2024, to 3 separate 1/8-acre fields. Additionally, KP has had 36,000 gallons or 9 tanker truck loads of this material removed by a septic hauler Brad S. Nicolas. A tanker was present and

Image 3: Image taken at Kingdom Provision displaying the pumping and removal of liquid waste.
Taken by Jonathan Bower on 3/14/2024

being loaded at the time of the inspection. KP should keep all land application logs and disposal documentation on site, in a way that they can be made available during inspections and complaint investigations.

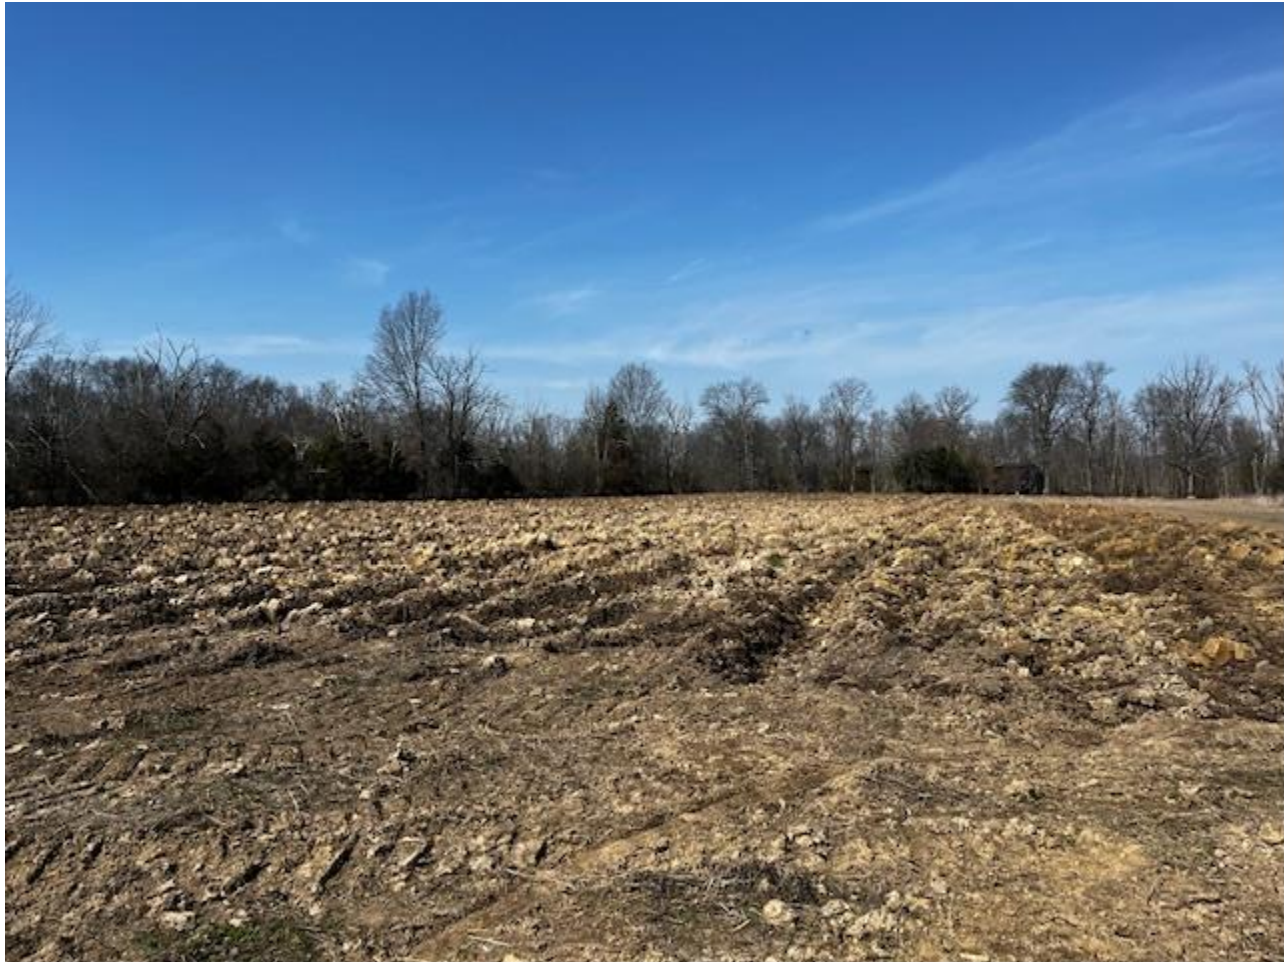
A site walk was conducted. From the road in the center of the site two of the fields had been further tilled. Standing water and/or FPR material was not observed during this site walk. The fields were too rough to easily walk across, so the property line was discussed from this location. It was explained that while an earthen berm was observed, it could be improved by keeping it off the fence line, shaped or graded to not allow standing water and vegetation or supporting root structure should be provided. It was also noted the there was a pool of water currently in this area that should be regraded.

Image 4: Image taken at Kingdom Provisions of the field where land application has occurred.
Taken by Jonathan Bower on 3/14/2024
