Department of Environmental Protection		GENERAL INSPECTION REPORT		Bureau of Land Recycling and Waste Management	
Type of Inspection	WM Identification Number	Entry Time/Date	Inspection ID		
Follow up inspection	Site ID: 865337	6/20/2024	3782574		
Facility/Incident Name and Location			Municipality		
Kingdom Provisions			Plumstead		
5960 Durham Road Pipersville PA 18947			County Bucks		
Name, Address of Responsible Official		Title			
Samir Hammed		Manager			
		Telephone	Interviewed		
		215-767-8943	Yes <input checked="" type="checkbox"/> No <input type="checkbox"/>

Department of Environmental Protection	GENERAL INSPECTION REPORT	Bureau of Land Recycling and Waste Management
Facility/Incident Name and Location		Municipality
Kingdom Provisions		Plumstead
5960 Durham Road Pipersville PA 18947		County Bucks

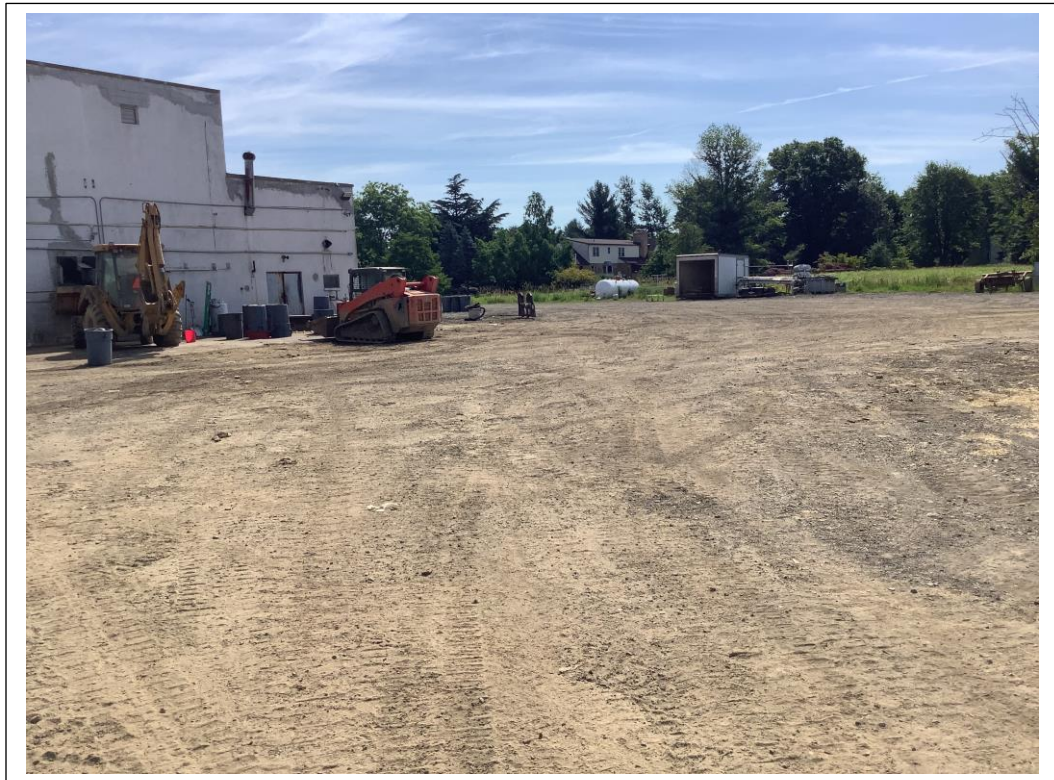
At the rear of the building there are 2 chutes, equipped with small conveyors where food processing residuals (FPR) from the butchering process exit the building. At the time of this inspection no containers designated for offsite reuse of FPR was observed. Two top load waste containers were present that are approximately 5 to 7 yards in capacity.

Image 1: Image taken behind animal processing building
Taken by Bedhr Salam Majeed on 6/20/2024

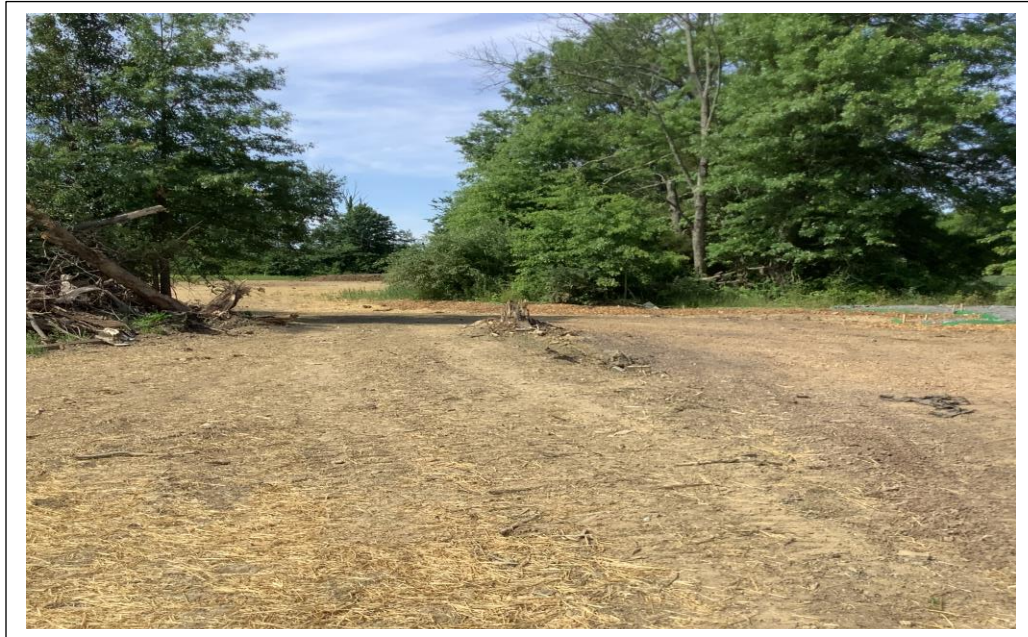
The site walk continued back to the composting area. FPR liquids have recently been applied on a field SE of the building adjacent to the roadway leading to the windrow piles. A very slight manure odor was detected walking past this field. The roadway that leads to the windrowed compost piles was free of animal remains and no pooling of FPR material was observed. A slight composting odor was detected approximately twenty feet from the compost windrows. The composting odor would decrease to no odor as you walked South to the back of the composting area. The composting area consisted of two (2) windrow compost piles approximately 50 feet in length, 8 feet in width and 4 feet in height. Pile #1 appears to have been managed, by turning material and providing cover in a way that this pile was sufficiently producing a compost material. Pile #2 also showed proper turning and cover sufficiently producing a compost material. No pooling of blood or FPR material were present around these windrow piles. No vectors were observed including turkey vultures were not present in air, near the compost piles or on the KP property, at the time of the inspection. Brent stated previously degraded compost was getting mixed into both piles as this material was enhancing KP compost efforts. DEP asked if additional lifts of woodchips could be applied to both windrow piles. Samir and Brent both agreed to do so. A delivery of wood chips is expected on site 6/20/2024.

Image 2: Image of the roadway leading to the windrow composting piles.
Taken by Bedhr Salam Majeed on 6/20/2024.

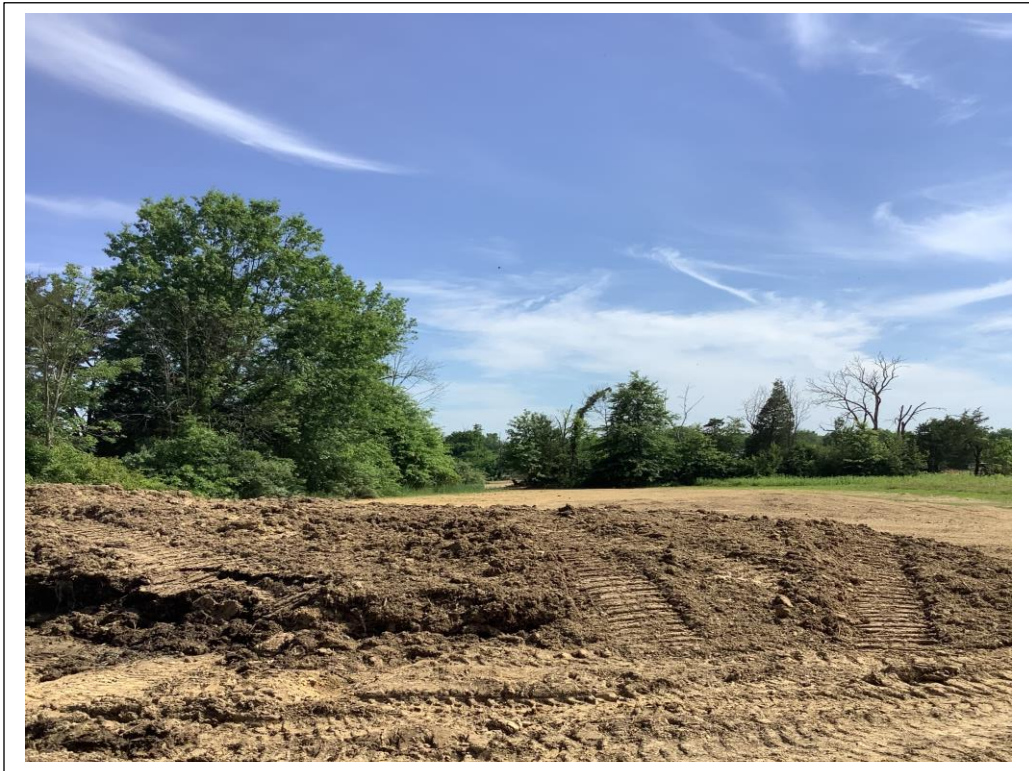
Image 3: Image of the compost windrow piles.
Taken by Bedhr Salam Majeed on 6/20/2024.

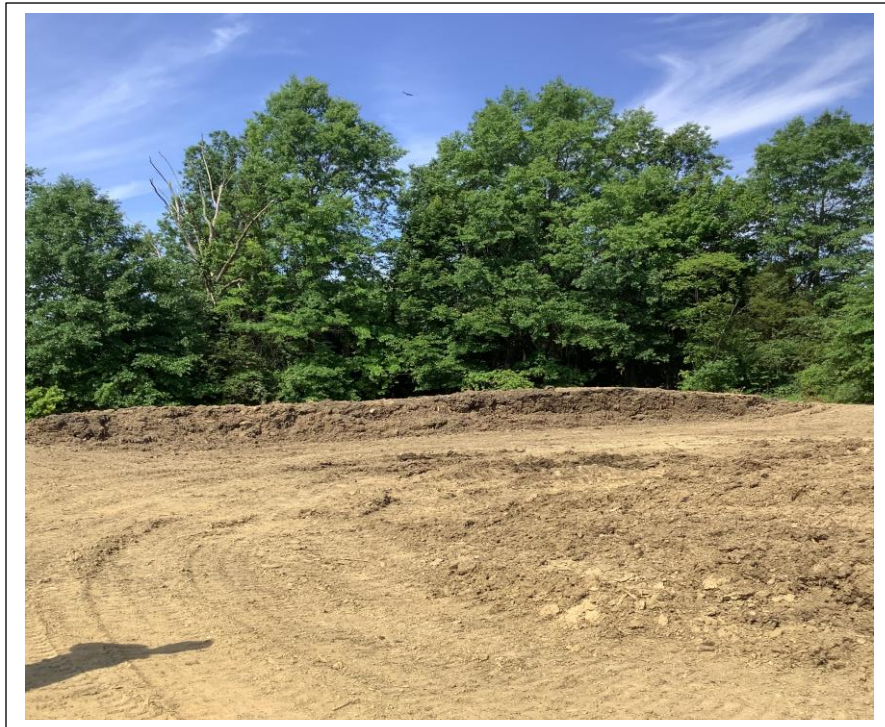
Image 4: Image of the compost windrow piles.
Taken by Bedhr Salam Majeed on 6/20/2024.

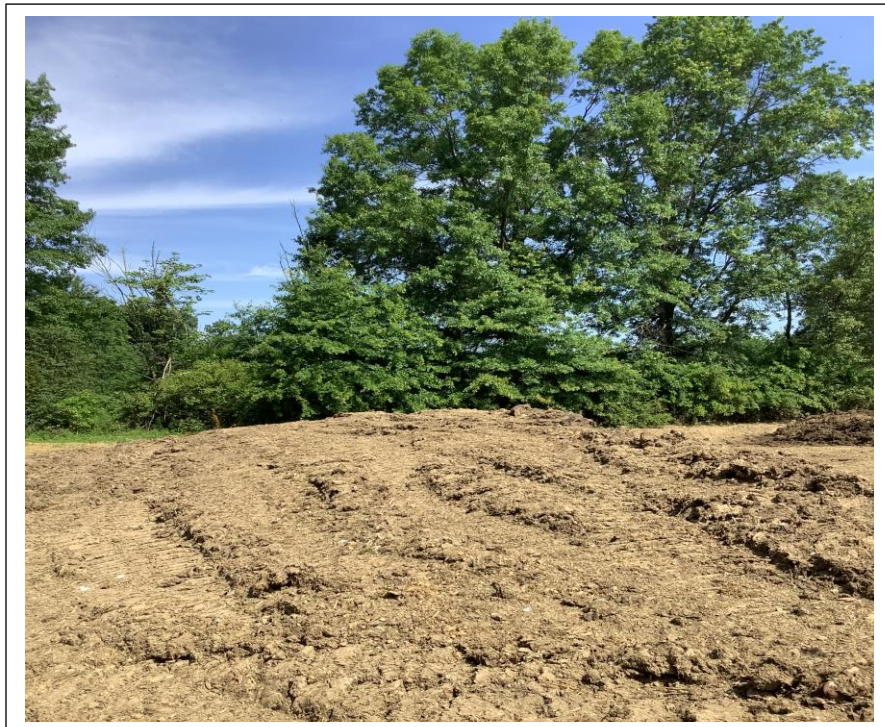
Image 5: Image of the compost windrow piles.
 Taken by Bedhr Salam Majeed on 6/20/2024

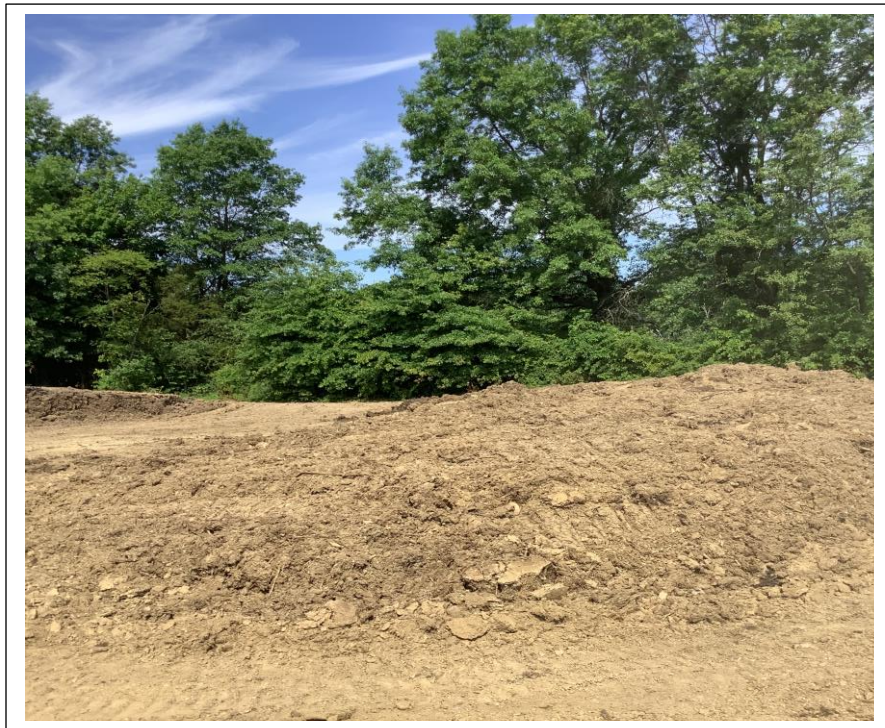
Image 6: Image of the compost windrow piles.
Taken by Bedhr Salam Majeed on 6/20/2024

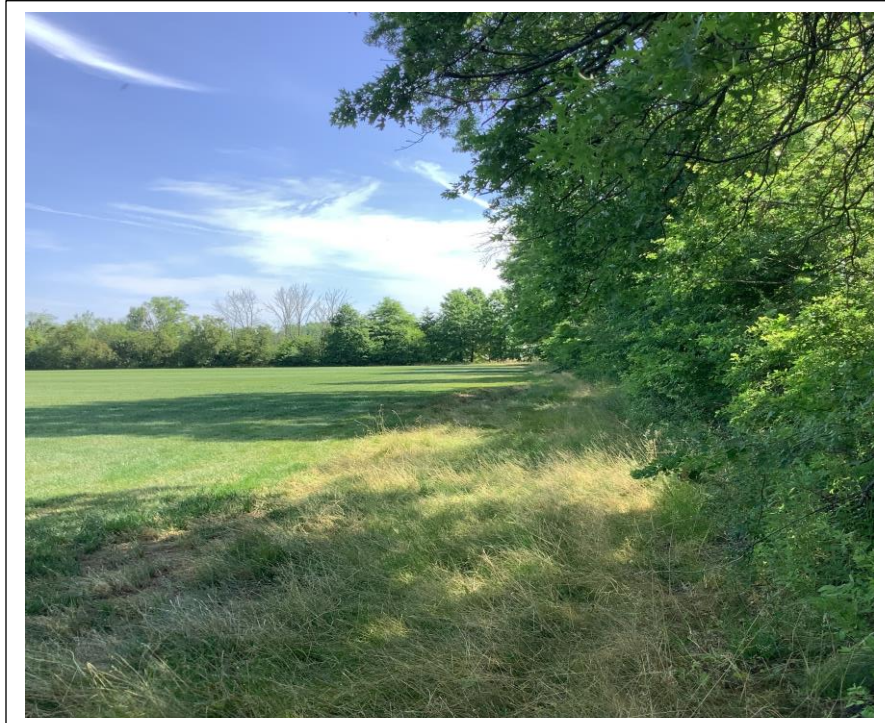
The walk continued through the field West of the composting area. No FPR material or composting material were found in this field, on the property line or deposited on other areas of the property. Odors like the odors observed in the compost area were not detected in this field nor at the North or South side of the building. The odors observed in the compost area were not observed off site at the time of this inspection.

Image 6: Image of the field adjacent to windrow piles looking North.
Taken by Bedhr Salam Majeed on 6/20/2024
