2700-FM-BAQ0023 2/2015 <b>pennsylvania</b> DEPARTMENT OF ENVIRONMENTAL PROTECTION		<b>INSPECTION REPORT</b>		Commonwealth of Pennsylvania Department of Environmental Protection Air Quality Program	
Date(s) of Inspection: 10/12/23	TV <input type="checkbox"/> SM <input type="checkbox"/> NM <input type="checkbox"/>	PA <input type="checkbox"/> GP <input type="checkbox"/> MEGA <input type="checkbox"/>	Permit #(s): _____	Expiration Date: _____	Case #: _____ PF ID #: 868000
Company Name: Kingdom Provisions		Municipality: Plumstead Twp		County: Berks	
Plant Name: Same as above		Physical Location: Same as below		Federal ID — Plant Code #:	
Responsible Official: Kerry Rush			Mailing Address: 5960 Durham Rd. Pipersville, PA 18947		
Title: Owner			Phone #(s): 215-260-5135		
<b>Mark (X) All Inspection Types That Apply To This Inspection:</b>					
<input type="checkbox"/> Full Compliance Evaluation (FCE)	<input type="checkbox"/> Plan Approval Inspection	<input type="checkbox"/> File Review (FR)

Kingdom Provisions

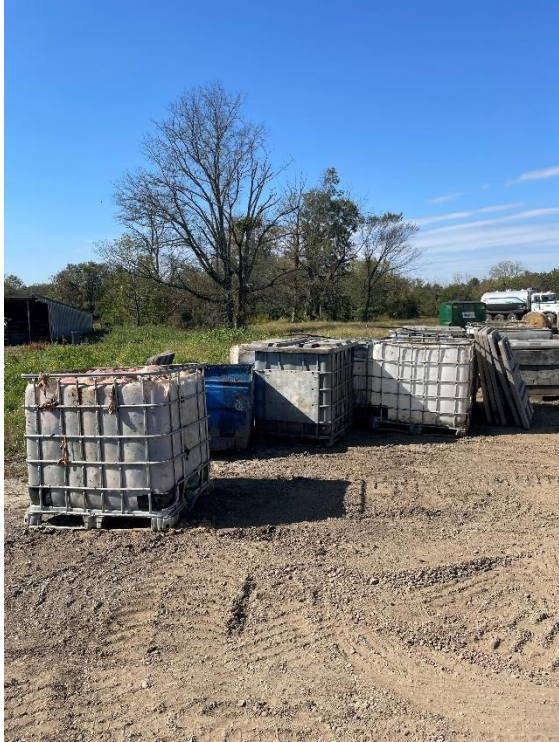
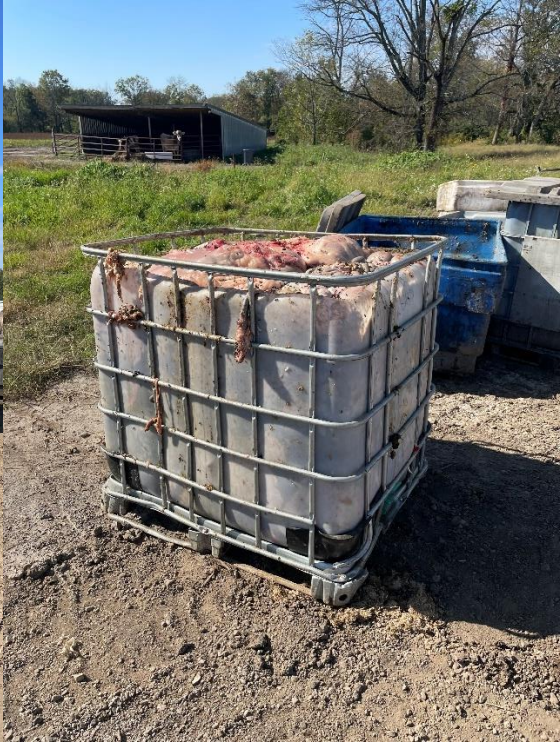
Photos 1 and 2 – Rendering bin storage area with a couple rendering bins that were uncovered and full and/or had not been rinsed out

<input type="checkbox"/> File Review	<input checked="" type="checkbox"/> Pre-Inspection Briefing	<input checked="" type="checkbox"/> Exit Interview/Briefing			
<input checked="" type="checkbox"/> Pre-Inspection Observations	<input type="checkbox"/> Check For New/Unreported Sources	<input type="checkbox"/> Sample(s) Collected			
<input type="checkbox"/> Visible Emissions Observations	<input type="checkbox"/> Verify Operation of CEMS	<input type="checkbox"/> Other			
<b>Comments/Recommendations:</b> Enforcement since last FCE <input type="checkbox"/> Yes <input type="checkbox"/> No (If yes, attach summary)					
Molly Goodman (DEP waste) and I arrived on site at 2:00 PM to conduct a Complaint Inspection. We met with Kerry Rush who showed us to the rendering bin storage area and the dumpster area. I noted a strong rendering/decomposing type odor in those areas that appeared to be present only within those areas. Winds were W at 3mph at the time of inspection, and it was sunny and 70°F. A couple rendering bins were uncovered and the full and/or had not been rinsed out. Mr. Rush instructed workers to cover the bins with plastic and lids, which they did. Mr. Rush stated that they are waiting to get new bins which have a tighter seal to better

Control odors, however the bins are on back order. Ms. Gooden and I also recommended covering the top of the dumpster with plastic since it doesn't have a tight seal either. The dumpster lid and side door were closed. I noted a few animal remains/fat on the ground near the bins and dumpster, and Mr. Rush said they would be immediately cleaned up going forward. I noted that the salted hide trailer was moved closer to the building and the remains that were near the previous location had been removed. The former compost area appeared more level and I noted very little standing water. Mr. Rush stated that MORAL still comes to pick up renderings on Mondays, Wednesdays, and Fridays, and waste management comes to empty the dumpster on Tuesdays and Thursdays. I observed waste management empty the dumpster at 3:08 PM, and I noted rendering/decomposing odors in the facility's driveway at that time. Mr. Rush stated that they are still not burning/singeing animal carcasses/hair and they are still planning to purchase a refrigerated trailer. I observed a truck come to empty an underground tank that stores wastewater and blood from the facility, which did not appear to cause odors.

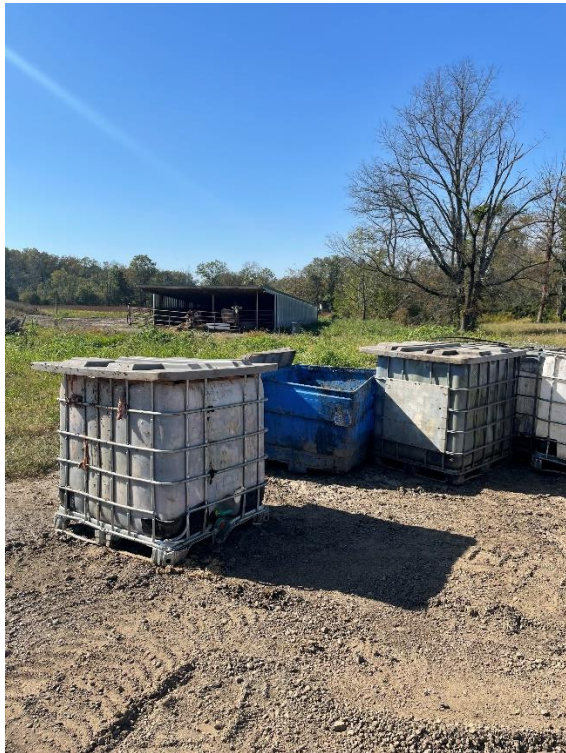
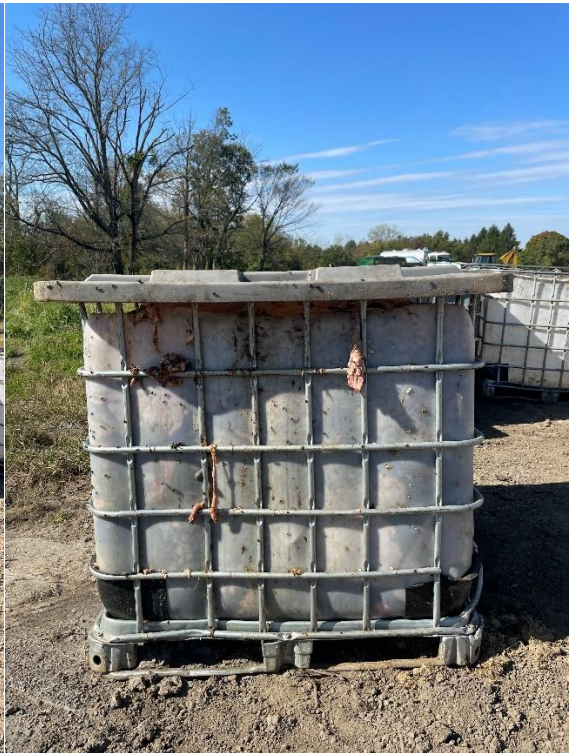
Photos 3 and 4 – Rendering bin with lid placed on it which did not make a tight seal

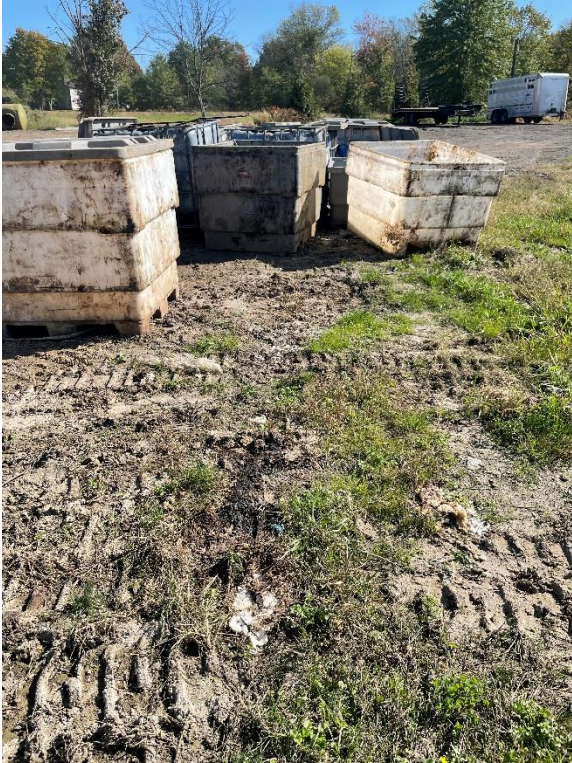
Photo 5 – A few animal remains/fat on the ground near the rendering bins  
Taken by Jennifer Ramos-Buschmann on 10/12/23, 2:15 PM

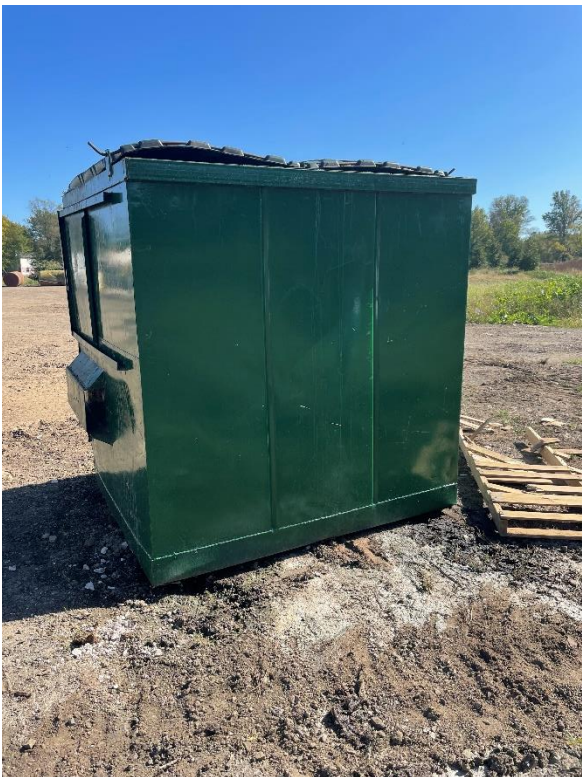
Photo 6 – Dumpster with side door and lid closed which did not make a tight seal  
Taken by Jennifer Ramos-Buschmann on 10/12/23, 2:18 PM

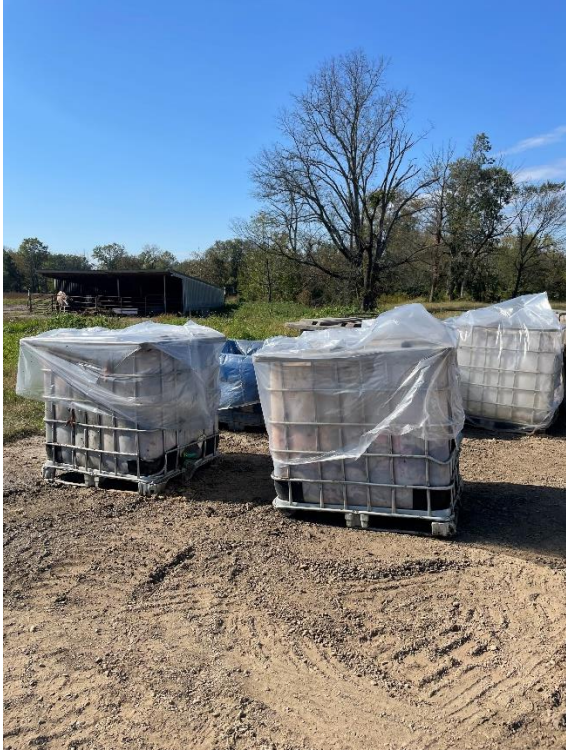
Photo 9 – Rendering bins which were covered in plastic  
Taken by Jennifer Ramos-Buschmann on 10/12/23, 2:23 PM

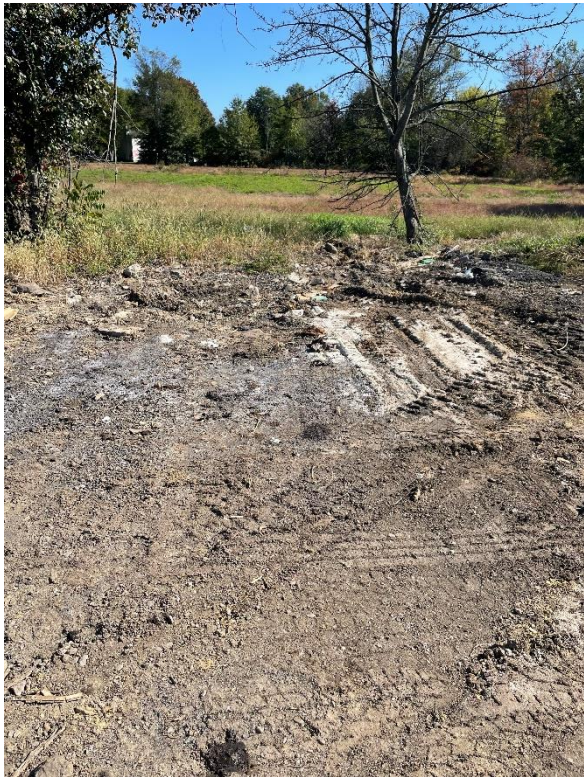
Photo 10 – Previous location of salted cow hides trailer with remains on ground removed  
Taken by Jennifer Ramos-Buschmann on 10/12/23, 2:24 PM
