2700-FM-BAQ0023 2/2015 pennsylvania pepartment of environmental. pepartment of pentilonmental.		INSPECTION		N REPORT		Commonwealth of Pennsylvania Department of Environmental Protection Air Quality Program		
Date(s) of inspection: TV PA GP GP		Permit #(s):	Expiratio	n Date:	Case	; #:	PF ID #:	
3   15   AY   NM   MEGA	1		* Apparation				868000	
Company Name:  KIN 1 Jam Pay 15 11 11 5	- 1	Municipality: Plum Stend	TIMO		County:		***************************************	
Kingdom Pavis in 5 Plant Name:		Plum Stead Physical Location:	, 1		Federal ID — Plant Code		#:	
Same as above Same as Responsible Official:			biling Address:					
Ephriam Shitzfus								
Title: Owner			15940 Durham Rd. Pipersville, PA 18947					
Ph		ripu	7011(~)	1'	1 10111			
267 -914 - 7430								
Mark (X) All Inspection Types That Apply To This Inspection:								
Full Compliance Evaluation (FCE)		Plan Approval Inspection				File Review (FR)

2700-FM-AQ0024 Rev. 2/99  pennsylvania  bepartment of environmental protection	INSPECTION REPORT Continued until Mond	Commonwealth of Pennsylvania Department of Environmental Protection Air Quality Program
<u> </u>	ndurny haster so he	15 taking the weste
offsite to be compi	ste

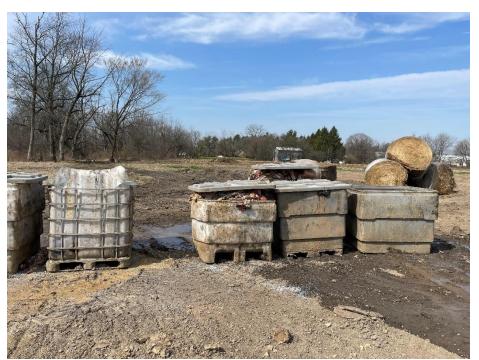
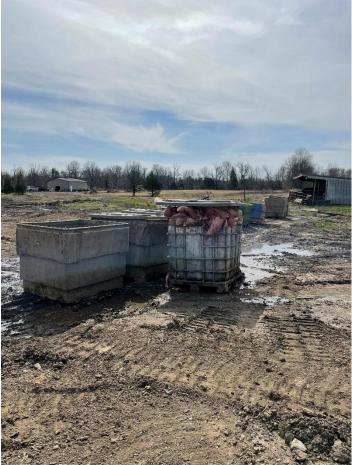
odors next to the rendering bins some of which were not								
Fully Closed/seded. Ms. Pressley Said they were being picked up								
today. I rejucyt that they be completely closed going forward. The								
odors appeared to my be present in that monedate weather								
walked to the ficks where the mneral /wash water / 600d is								
Spread and filled deeply motor the ground. I wited no edws in the								
flete area. Mr. Pressley Said Mat MI)PAC 15 hurrently mardown								
Compliance Status: 🌠 In 🔲 Out 🔲 Pending 🔲 Awaiting Co. Re				Report Needs a Follow-Up Inspection? Yes No				
Company Representative: Title:			Signature: Date:					
Amber Pressice Plant manager (Mbel 1989) 3/3/3/DEP Representative: Date/Time: Date/Time: Date/Time:						3   13   34 Date/Time:		
This document is official notification that a representative of the Department of Environmental Protection, Air Quality Program, inspected the identified site. The findings of this inspection are shown above and on any attached pages, and may include violations uncovered during the inspection. Violations may also be discovered upon review of

Photos 1 and 2 – Rendering bins, some of which were not fully closed/sealed Taken by Jennifer Ramos-Buschmann on 3/13/24, 1:40 PM and 1:51 PM

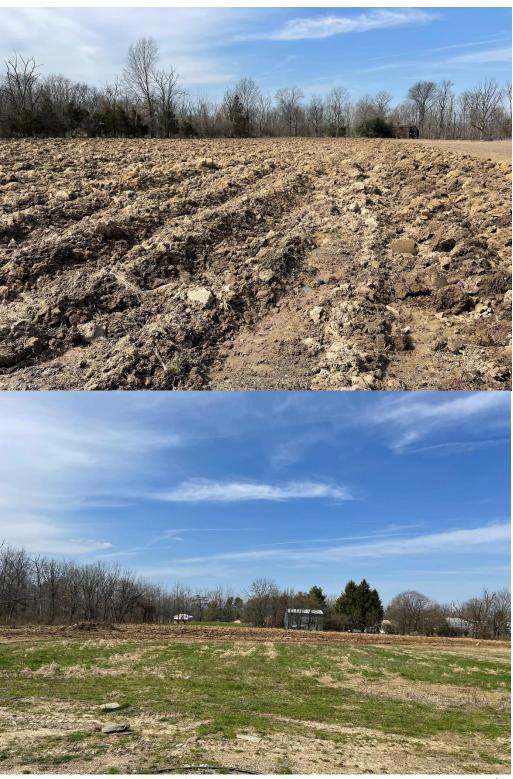
Photos 3 and 4 – Two of three fields where FPR (Food Processing Residual: mineral/wash water/blood) is spread and tilled deeply into the ground Taken by Jennifer Ramos-Buschmann on 3/13/24, 1:43 PM and 1:51 PM
