Department of Environmental Protection	GENERAL INSPECTION REPORT	Bureau of Land Recycling and Waste Management
-------------------------------------------	------------------------------	--------------------------------------------------

Type of Inspection <b>Complaint Investigation</b>	WM Identification Number <b>Site ID: 865337</b>	Entry Time/Date <b>6/6/2023</b>	Inspection ID <b>3569822</b>
Facility/Incident Name and Location <b>Kingdom Provisions 5960 Durham Road Pipersville, PA 18947</b>			Municipality <b>Plumstead</b>
Name, Address of Responsible Official <b>Kerry Rush</b>			Title <b>Owners / Operators</b>
Name, Address of Responsible Official <b>Ephriam Stoltzfus Brent Pressley</b>		Telephone <b>215-767-8943</b>	Interviewed <b>Yes <input checked="" type="checkbox"/> No <input type="checkbox"/></b>

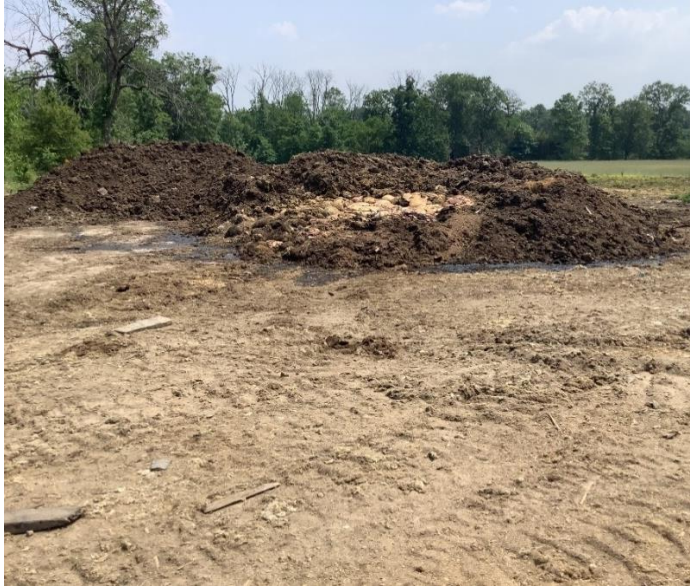
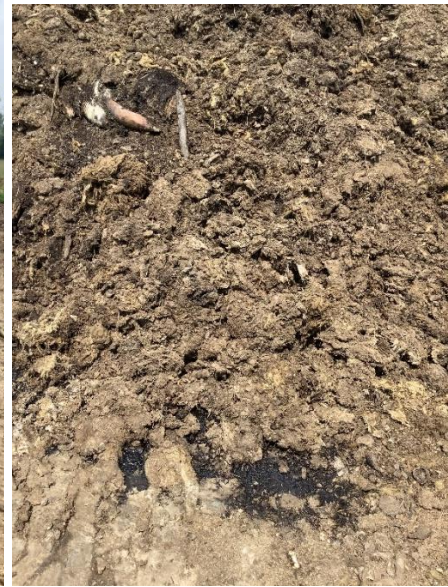
The compost pile (Image 1) was observed to be completely confined to the concrete pad. Mr. Rush stated that animal remains are layered with a mixture of animal waste and saw dust/wood that is received from Heacock Lumber. The majority of the pile was covered except for some exposed material recently placed onto the pile. Kingdom Provisions should provide cover upon the placement of any material. Based on a visual inspection, it appeared that no other materials have been mixed in or added to the compost.

Image 1: Compost Pile (left), Compost (right)  
Taken by Molly Goodman on 6/6/2023

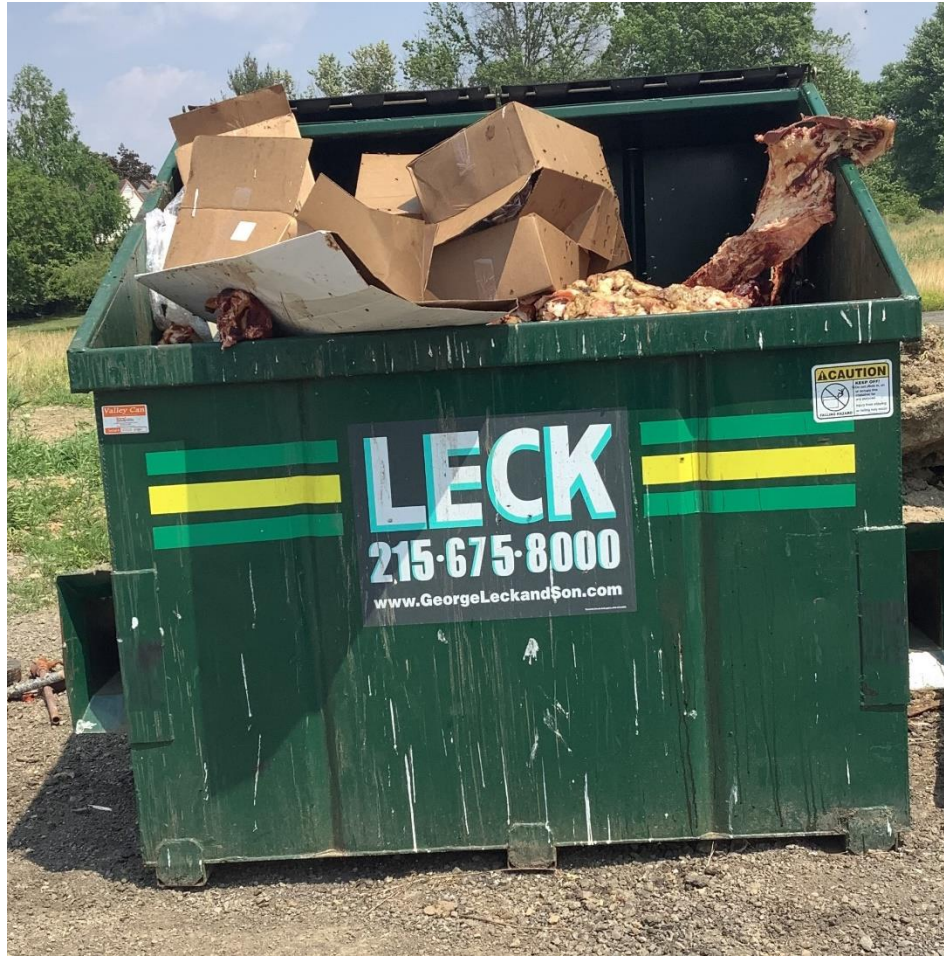
Mr. Rush additionally suggested the odor is coming from a container located behind the slaughterhouse. Noticeably strong odors of decaying animal remains were detected within approximately 20' of the container. Mr. Rush stated that the container was used for waste bones and fat. Primarily cardboard and remains of slaughtered animals were observed in the container (Image 2) and debris, including parts of an animal carcass, was observed outside the container (Image 3). Upon closer inspection, the container was observed to harbor a large number of vectors (Image 4). **Kingdom Provisions failed to store putrescible waste in a container that is sealed, watertight, leak proof, insect-proof and rodent-proof contrary to 25 PA Code 299.121(c) and did not minimize and control conditions that create a public nuisance, contrary to 25 PA Code 299.115(a) and (b).** Mr. Rush stated that the waste will be removed from the site in a timely manner and documentation will be provided that will demonstrate the waste has been disposed of properly.

Image 2: Container at Kingdom Provisions  
 Taken by Molly Goodman on 6/6/2023

**Kingdom Provisions should respond within 10 days of receipt of this inspection report with documentation in the form of a disposal receipt demonstrating the proper disposal of the putrescible waste in the dumpster. Furthermore, Kingdom Provisions should provide a plan describing future waste handling from the slaughtering operation.**

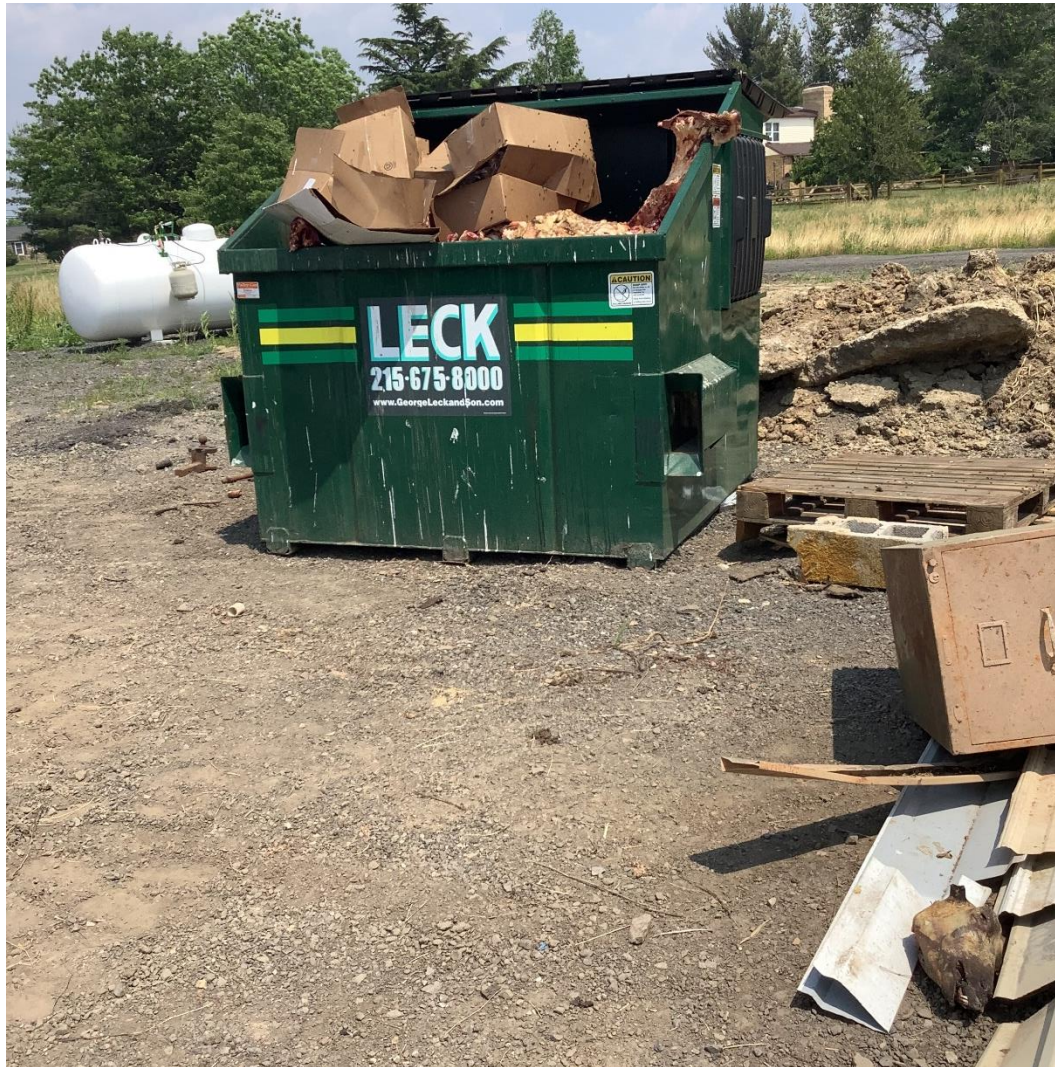
Image 3: Dumpster containing cardboard, animal remains, and surrounding debris  
 Taken by Molly Goodman on 6/6/2023

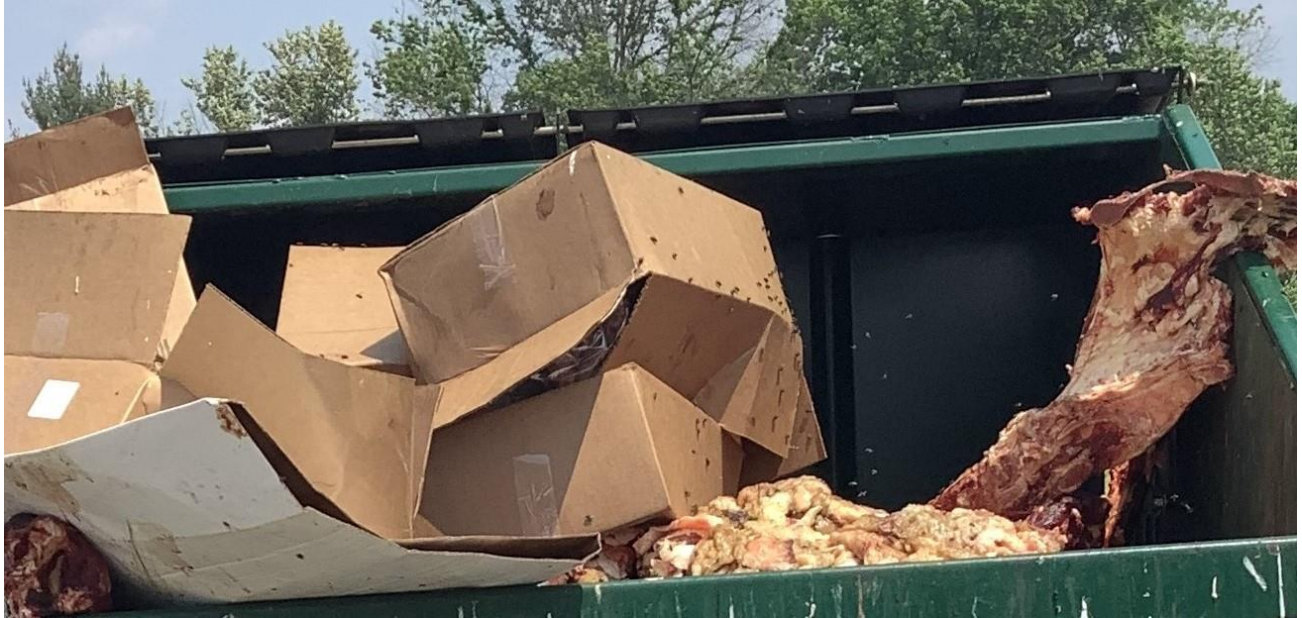
Image 4: Vectors observed in the container  
Taken by Molly Goodman on 6/6/2023

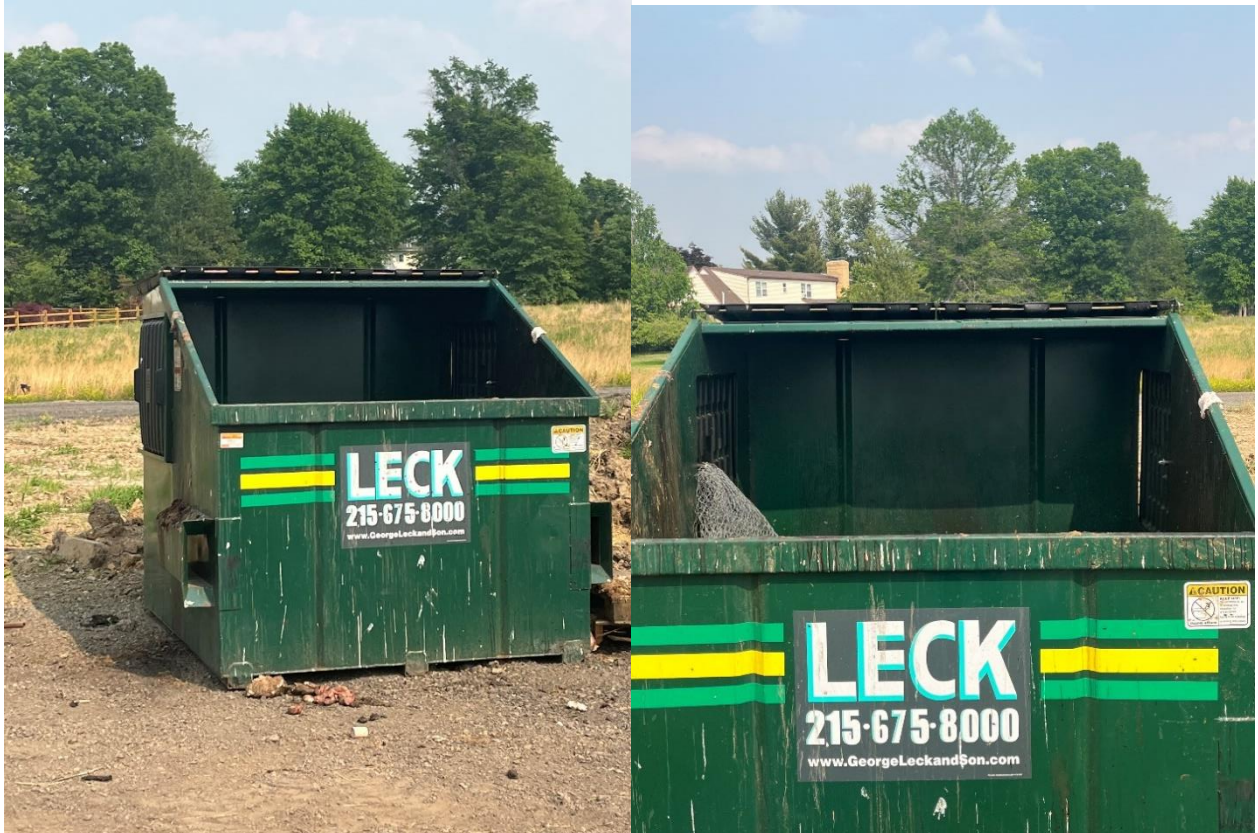
Mr. Pressley stated that the container is regularly picked up on a weekly basis and was able to provide photographs (Image 5) of the empty container. The Department has not yet received waste receipts or other documentation to indicate the waste was received by a disposal facility. Mr. Pressley was reminded that the container must be maintained (by cleaning, covering, and emptying) on a regular basis to prevent any odor problems and no waste should be stored on the ground surrounding the container

Image 5: Photographs of container that appears emptied  
 Provided by Brent Pressley on 6/8/2023
