2700-FM-BAQ0023 2/2015 pennsylvania pepartment of environmental protection		INSPECTION	N REPORT		Commonwealth of Pennsylvania Department of Environmental Protection Air Quality Program			
Date(s) of Inspection: TV PA	ŧ	Permit #(s):	Expiration	n Date:	Case	#:	PF ID #:	
			·		***		868000	
Company Name: Kngdom Provisions Plumstead Plant Name: Physical Location:		Plumstead	Tup		County: Bucks			
		ž.	Federal ID — Plant Code #:		: 			
Responsible Official:			Mailing Address:					
Brent Pressley			5160 Ourham Rd.					
Brent Pressley Title: Plant Manager Phone #(s):			5960 Ourham Rd. Pipersville, PA 18947					
Phone #(s): 215 - 767 - 8943								
Mark (X) All Inspection Types That Apply To This Inspection:								
Full Compliance Evaluation (FCE)		Plan Approval Inspection	n		File Review (FR)			
Operating Permit Inspection (PI)		Initial Permit Inspection (IPI)			X	Complaint Inspection (CI)		
Routine/Partial (RTPT)		Follow-Up Inspection (Ref. Date:)				Sample Collection (SC)

2700-FM-AQ0024 Rev. 2/99 pennsylvania DEPARTMENT OF ERVIRONMENTAL PROTECTION	INSPECTION REPORT Continued	Commonwealth of Pennsylvania Department of Environmental Protection Air Quality Program					
a newer employee ha	d

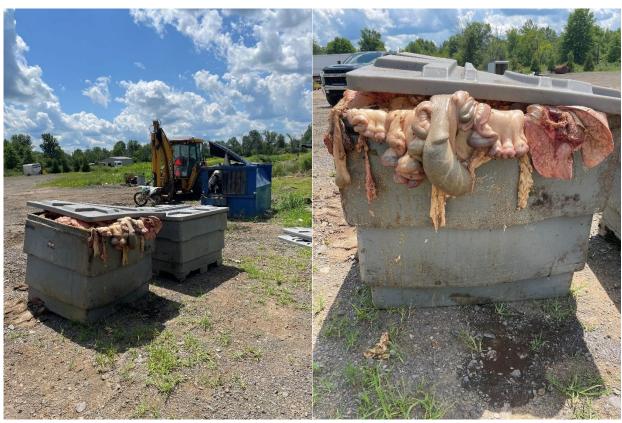
Photos 1 and 2 – Containers of entrails of slaughtered animals Taken by Jennifer Ramos-Buschmann on 7/31/23, 12:50 PM

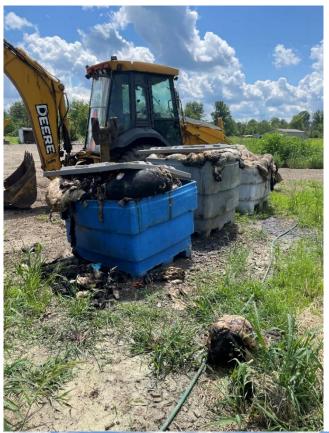
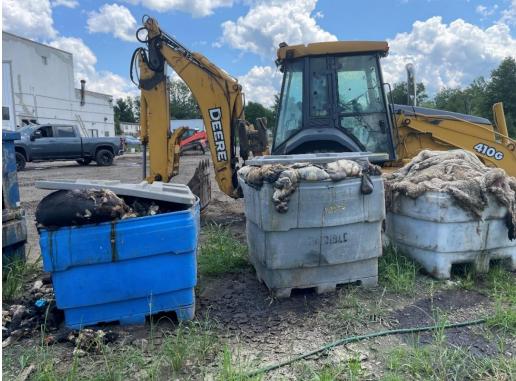
and partially closed rendered bing filled with animal remains 1 skins								
			<u>M1</u>	14 11	<u>u</u>	animal	remains sking	
bones in the bin of a front end loader. Ms. Prissley Stated that								
the Us were previously chised, but the inner organs expand in the								
heat and caused the lies to open. Ms. Pressley also stated that								
Compliance Status: ☐ In ☐ Out ☒ Pending ☐ Awaiting Co. R			Report Needs a Follow-Up Inspection? Yes No					
Company Representative:	Title	Office		Signature:			Date:	
Amber Pressley	7	nanager		mber 885 731/25			73123	
DEP Representative:	P Representative: Signature: Date/Time:					Date/Time: 7/31/23		
JUNIO TEAMOS-BUSCHMann MG SPECIALISI JUNIO 144MB-BUENNAM 3125pm								
This document is official notification that a representative of the Department of Environmental Protection, Air Quality Program, inspected the identified site. The findings of this inspection are shown above and on any attached pages, and may include violations uncovered during the inspection. Violations may also be discovered upon review of sample results or from any additional review of Department records. Notification will be forthcoming, if such violations are noted.

Photos 3 and 4 - Containers of entrails, heads, and skins of slaughtered animals Taken by Jennifer Ramos-Buschmann on 7/31/23, 12:51 PM and 12:58 PM

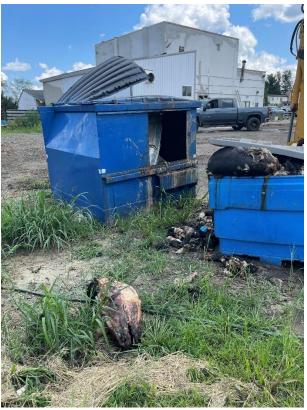
Photo 5 – Head and feet of slaughtered animals on ground adjacent to containers and dumpster Taken by Jennifer Ramos-Buschmann on 7/31/23, 12:58 PM

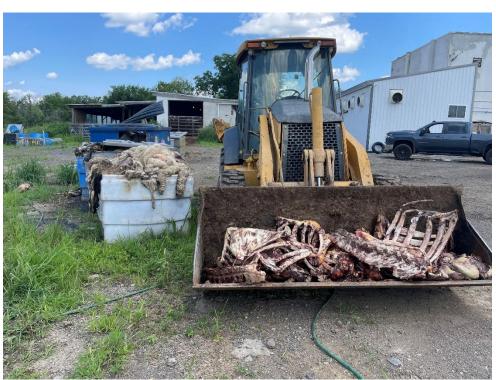
Photo 6 – Cow backbones stored in bucket of backhoe Taken by Jennifer Ramos-Buschmann on 7/31/23, 12:59 PM

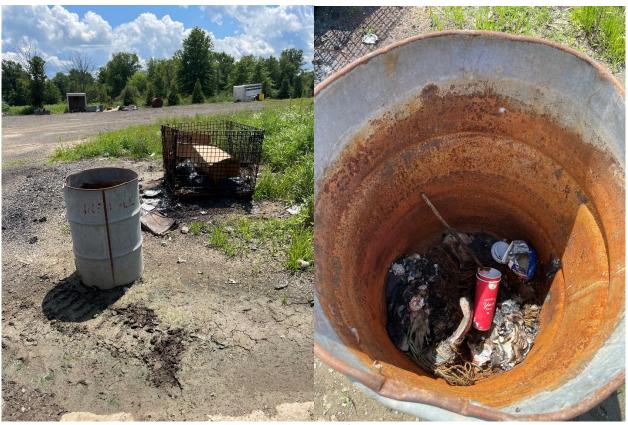
Photos 7 and 8 – Burn barrel containing a conglomerate of solid waste and animal remains Taken by Jennifer Ramos-Buschmann on 7/31/23, 1:02 PM

boxes hear the rendering bin area. Ms. Pressley stated that							
they bear cardboard boxes that conit be used for packaging							
meat. Informed her of the open burning regulation and							
requested that they carse open burning going forward. During							
my 7/12/23 MSpection, I noted Smoke compre from the facility's							
vents and something smoldering on the ground. Ms, Pressley							
Stated that they 50 metimes burn the har off an ma caprasses							
and before selling them, which is what causes the smoke, and							
the smoldering could have been from burning card board boxes, MS.							
Pressley Stated that they may be considering purchasing an minerator							
to dispose of unuanted animal remains. I explained that they would							
likely need an air quality permit to operate an momerator							
and I would email her more information on how to obtain a							
permit should they choose to do so. The compost pile was covered

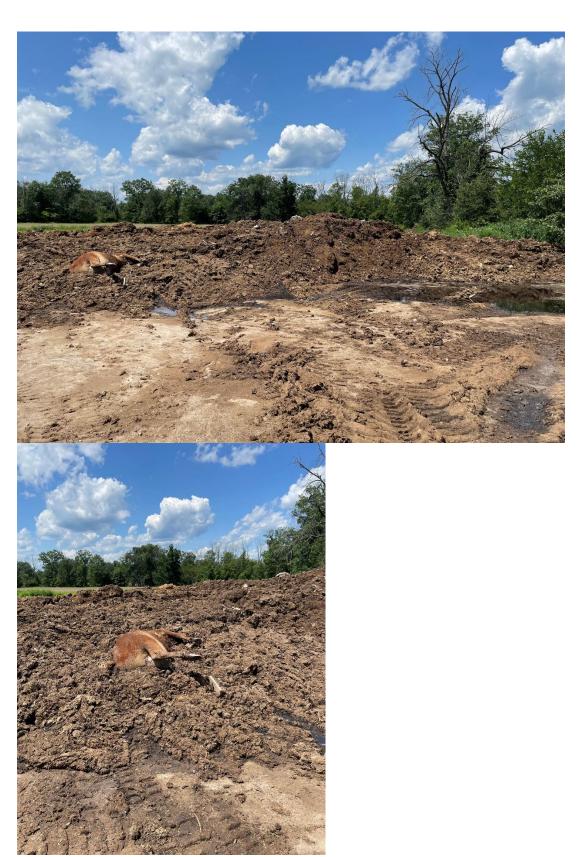
at the time of inspection except for a whole con curcuss							
which was not fully covered Ms. Pressley Stated that it was previously							
Covered but it expanded / became bloated in the heat which caused							
1+ to become uncarered, Ms. Coordinan and requested that it be covered							
Daving my 7/4/23 MSpection, Brent Pressley Stated Mat 300-400 animals							
are sixughtered at the facility a week, that some animals are							
purchased from auctions, and most of their customers are from							
Company plant name: Initials of representative interviewed: Date:							
1 1 1 1 1 1 1 1 1 1 1 1 1 1 1 1 1 1 1							
Page 2 of 2 MS. Pressley Stuted Hut Reviewed By							
The had a	not been notified by Plum	astead Thep to remove their					
Page 2 of 2 Ms. Pressley started that Reviewed By She had not been notified by Plumstead Thip to vemove they Compost pile in 30 days, Ms. Objection and I will reach out to the White-Site burnship regarding this matter

Photos 9 and 10 – Exposed cow carcass and discolored standing water in compost pile Taken by Jennifer Ramos-Buschmann on 7/31/23, 1:05 PM and 1:06 PM
