2700-FM-BAQ0023 2/2015 pennsylvania DEPARTMENT OF ENVIRONMENTAL PROTECTION		INSPECTION F		REPORT		Commonwealth of Pennsylvania Department of Environmental Protection Air Quality Program		
Date(s) of Inspection:		Permit #(s):	Expiration	n Date:	Case #:		10 #: 68000	
Company Name:	Municipality:				County:			
Ringdom Provisions Plant Name:		Physical Location:		Thip		Buks Federal ID — Plant Code #:		
Shane 45 A Silve		5 me as be		low Francisco		iai ID — Plant Code #:	ALL MANAGEMENT AND	
Responsible Official:			Bacting Address					
Shine AS Above Same as Responsible Official: Kerry Rush Title:			5940 Ourham Rd. Pipersville, pA 18947					
Ouner			Pipersville, DA 18947					
Phone #(s):				1171				
215-240-5135								
Mark (X) All Inspection Types That Apply To This Inspection:								
Full Compliance Evaluation (FCE)		Plan Approval Inspecti	Plan Approval Inspection			File Review (FR)	Target and the same of the sam

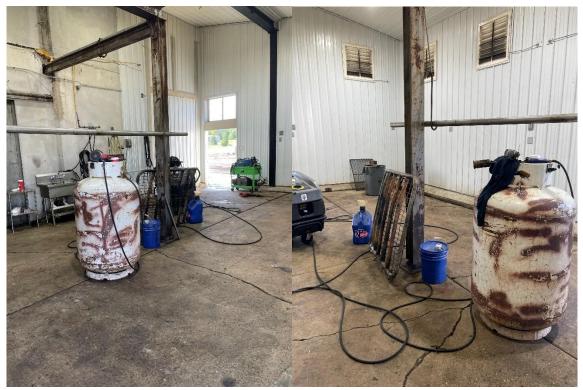
Molly Goodman and wrived on site at 10:50 AM to conduct a complaint the procession. We met with Kerry Rush who showed us around primarily the outside the facility. Mr. Rush showed us the part of the								
building that had been used for singeing animal carlasses. I ruted								
a propune sank that had a forch on top of it. Mr. Rush Stated								
that the tank is now gonnected to a water tub m an								
adjacent room and is used to heat the water so that the								
garagges are boiled in order to remove the har instead of								
burning the hair off, Mr. Rush Stated that they no longer								
Singe the Curcasses but was unsure of When exactly They Stopped.								
Compliance Status:			Report Needs a Follow-Up Inspection? Yes No					
Company Representative: Title:		Signature:			\supset	Date:		
Kerry fish	***************************************	Owner		Special			9-21-4	
DEP Representative:	Title			Signature:	Λ		Date/Time:

Photos 1 and 2 – Propane tank, torch, and vents in room that was used for singeing animal carcasses Taken by Jennifer Ramos-Buschmann on 9/21/23, 10:54 AM and 10:55 AM

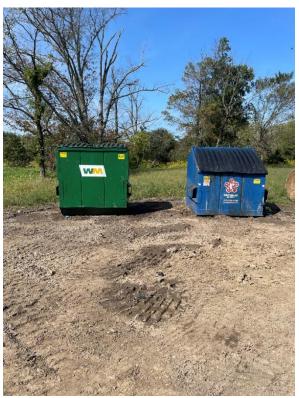
2700-FM-AQ0024 Rev. 2/99 pennsylvania perarthent of environmental protection	INSPECTION REPORT Continued	Commonwealth of Pennsylvania Department of Environmental Protection Air Quality Program					
We then Walked to	the trash bin area	and losserved a					
Republic bin and a new waste han a general bri. Mr. Rugh Said							
that they are no longer using Roublic because they said the							
him was soo heavy to pick up. So they we now using waste							
Management but Mr. Rush was not sive how offen they							
come to empty the brn, Mr. Rush Stated that Waste							
Management picks up the Sheep 5KMS, and the cow hides							
are how salted and sold to sume one who lomes once a							
week to pock them up. I observed the salted hides are							
Stored Ma trailer; I set did not note adors coming from that							
trailer. I upted rendering type adors near the trash bins							
and the empty and foll bendering bins , the days appeared

Photo 3 –Republic and new Waste Management dumpsters located behind slaughterhouse Taken by Jennifer Ramos-Buschmann on 9/21/23, 11:03 AM

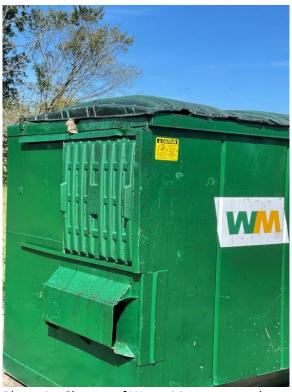
Photo 4 – Closeup of Waste Management dumpster with flies and animal remains hanging out Taken by Jennifer Ramos-Buschmann on 9/21/23, 11:04 AM

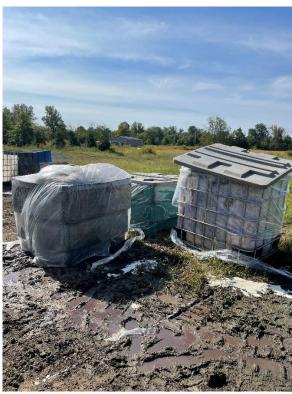
to be present only within those immediate wens, losserves							
4 full rendening birds that were covered in plastic and							
several empty renduling bing that had fat and other							
remains partially strick to them, there was also some liquid							
Evesidue on the grow							
Mopal came and picked up bins on Monday 9/18/23 and							
Wednesday 9/20/25 but they lest behind 4 bins on 9/20/23							
because their prick was kill which caused dars, Mr. Rush							
Said they are in the process of obtaining a refuldyerated C Box							
trailer to store the rendering bins going forward, but they heed							
to get a permit first and then will order the trailer; he hopes							
to get the trailer in the next few months, Mr. Rush Stated							
that they slaughter 10-20 cous a week on thesdays and							
about 200 Sheep a week, and Mopac Still comes on Mondays,							
Wednesdays, and fridays, we then observed the former compost

Photo 5 – Full containers covered in plastic bags that were seeping liquid from decomposing material Taken by Jennifer Ramos-Buschmann on 9/21/23, 11:05 AM

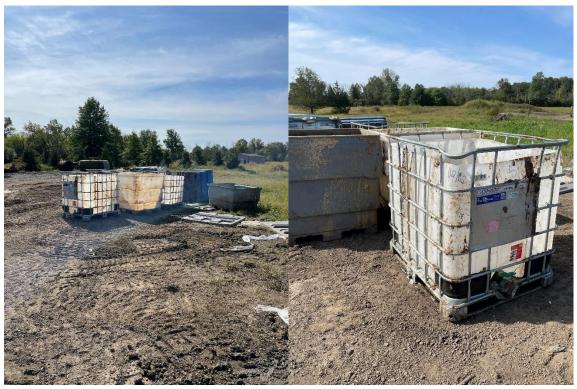
Photos 6 and 7 — Emptied containers to be cleaned that had animal remains partially stuck to them Taken by Jennifer Ramos-Buschmann on 9/21/23, 11:06 AM and 11:07 AM

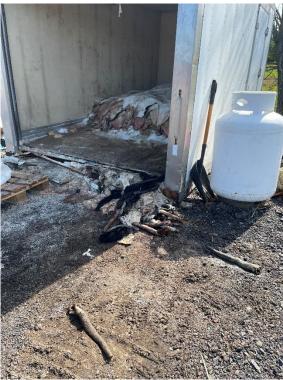
Photo 8 – Remains in front of salted cow hides Taken by Jennifer Ramos-Buschmann on 9/21/23, 11:10 AM

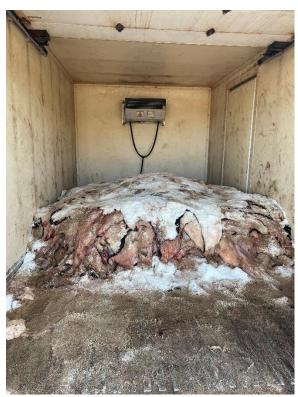
Photo 9 – Salted cow hides inside trailer
Taken by Jennifer Ramos-Buschmann on 9/21/23, 11:10 AM

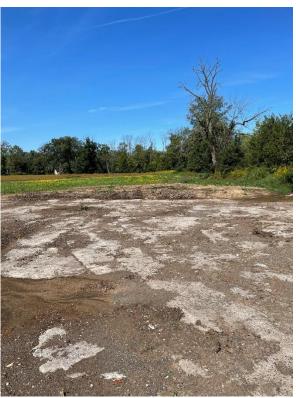
pile area and there is appeared to be no new material added.							
there was some Standing water on top of the small pile							
that remains and I noted a faint odor in that area, I noted minor							
fleeting rendering odors in the facility's diveway that appeared to be							
curried by the wind. I remposed Mr. Rush that burning Brigging the							
Company plant name: Initials of representative interviewed: Date: 9 21 22							
Kingdom Provisions	KPR	7-21-23					
Page 2 of 2 Reviewed By							
Mr. Rush Stated that the divty rendering bing would be cleaned today an							
[055 eved 50me waste [] White - Site	bing bethe washed while District Office	I was in 58te. Pink - Regional Office

Photo 10 – Pad formally used for composting Taken by Jennifer Ramos-Buschmann on 9/21/23, 11:14 AM

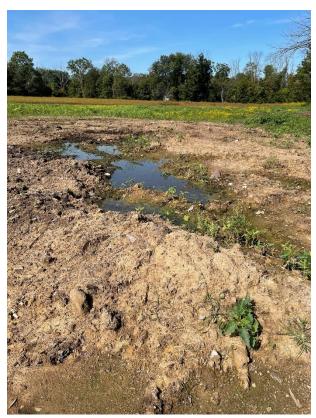
Photo 11 – Standing water on material moved from compost Taken by Jennifer Ramos-Buschmann on 9/21/23, 11:15 AM
