<h1>INSPECTION REPORT</h1>		Commonwealth of Pennsylvania Department of Environmental Protection Air Quality Program	
Date(s) of Inspection: 4/16/24	TV <input type="checkbox"/> SM <input type="checkbox"/> NM <input type="checkbox"/>	PA <input type="checkbox"/> GP <input type="checkbox"/> MEGA <input type="checkbox"/>	Permit #(s): _____	Expiration Date: _____	Case #: _____	PF ID #: 868000
Company Name: Kingdom Provisions			Municipality: Plumstead Twp		County: Bucks	
Plant Name: Same as above			Physical Location: Same as below		Federal ID — Plant Code #:	
Responsible Official: Ephraim Stoltzfus				Mailing Address: 5960 Durham Rd. Pipersville, PA 18947		
Title: Owner				Phone #(s): 267-914-7430

Company -- plant name:
Kingdom Provisions

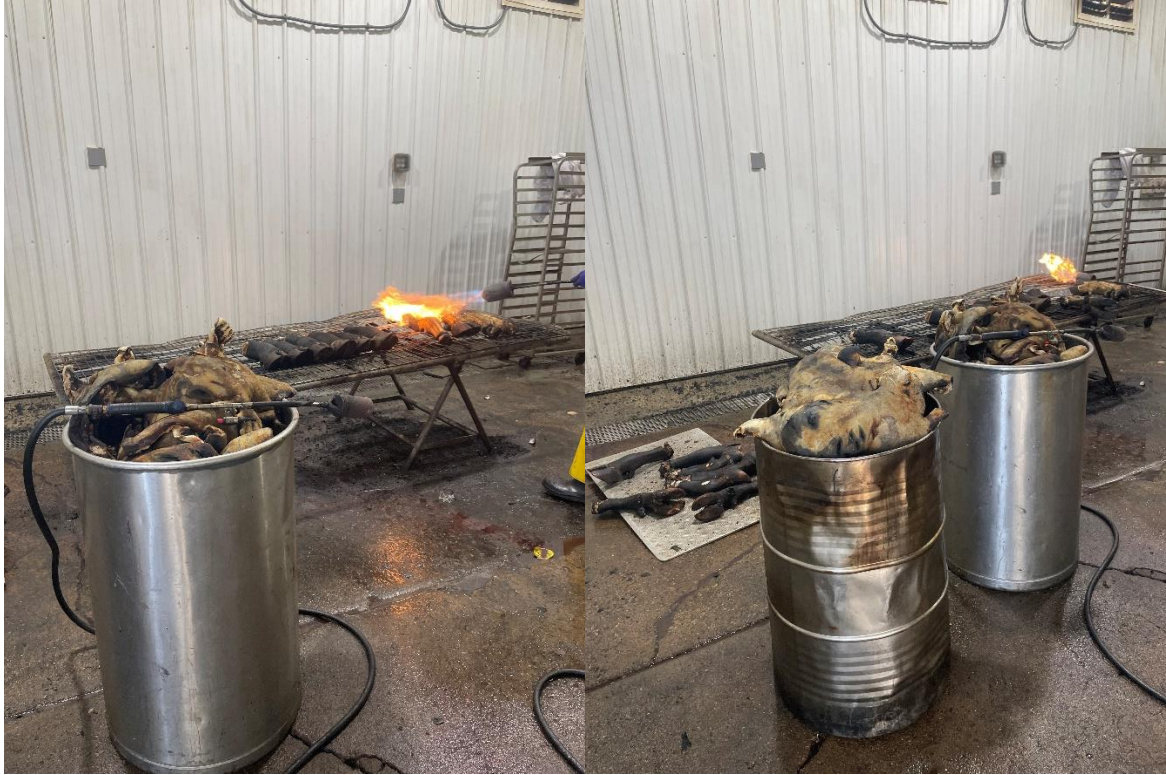
Photos 1 and 2 – Singeing room with singeing actively taking place in Photo 1
Taken by Jennifer Ramos-Buschmann on 4/16/24, 3:52 PM and 3:50 PM

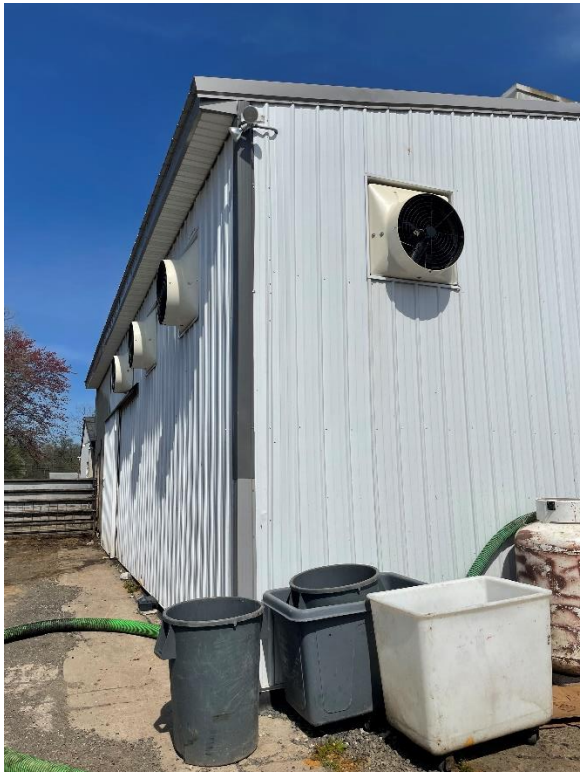
Photo 3 – Vents from singeing room
Taken by Jennifer Ramos-Buschmann on 4/16/24, 3:00 PM

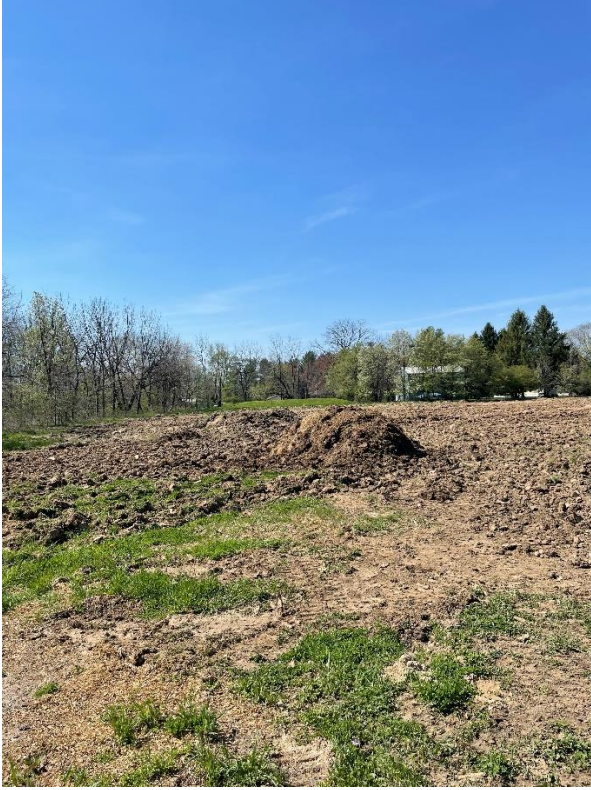
composting at the end of every day. I noted rendering odors near the truck. I also noted manure odors coming from two large piles of manure in the field to the right of the facility. Mr. Stoltzfus stated the barns were just cleaned and all the manure was removed and placed in the field. I observed salted and unsalted cow hides behind the facility; I did not note odors coming from them. Mr. Stoltzfus stated that they plan to begin composting the rendering animal remains again but in a field farther back on the property ~~also~~ within the next month. He stated it will be done properly this time and he is meeting with personnel from Plumstead Twp on 4/17/24 to discuss. I then walked along Durham Rd towards Stump Rd. and I noted burning hair and rendering odors at 3:25 PM and 3:41 PM. The odors appeared to linger for about 5-10 minutes. I spoke with a complainant who confirmed those were the odors they smelled throughout the day today and yesterday. Upon returning to the facility, I observed singeing was taking place again. Mr. Stoltzfus stated they singe animal body parts ~~throughout the day~~ throughout the day every day.

Photo 10 – Two piles of manure in the field to the right of the facility (when facing front of facility)
Taken by Jennifer Ramos-Buschmann on 4/16/24, 3:14 PM
