Company Name: **Kingdom Provisions** Municipality: **Plumstead Twp** County: **Bucks**

I arrived on site at 2:35 PM to conduct an odor complaint inspection. Prior to arriving on site, I noted decomposing odors and occasional burning hair odors along Durham road and at a complainant's property. The odors were strong at times and came and went with the wind consistently for the 30 minutes that I was there. Winds were W at 11 mph and it was mostly sunny and 81°F. I noted the same odors upon arriving at the facility. I met with Ephraim Stoltzfus who said that the odors were due to the ~~house~~ heads not being picked up when they were supposed to from Holley at 6:00 AM this morning. I walked to

INSPECTION REPORT

Commonwealth of Pennsylvania
Department of Environmental Protection
Air Quality Program

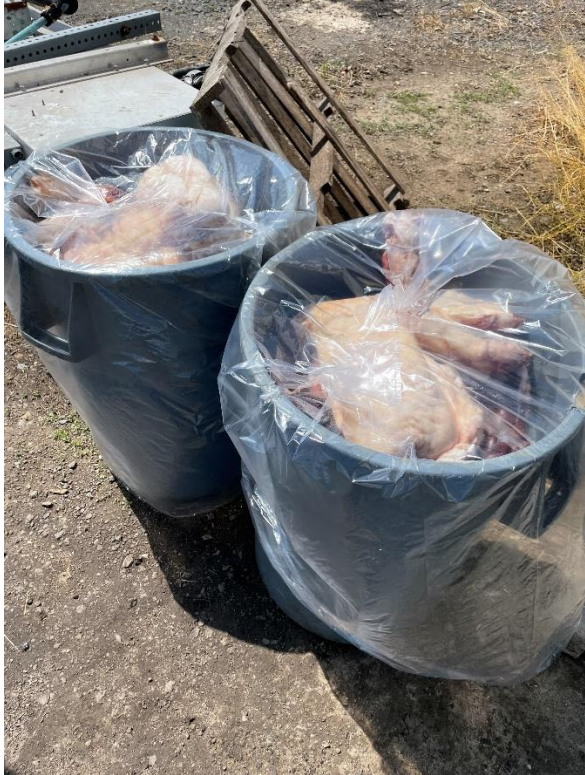
Photo 1 – Trash bins filled with fat covered in plastic
Taken by Jennifer Ramos-Buschmann on 5/8/24, 2:41 PM

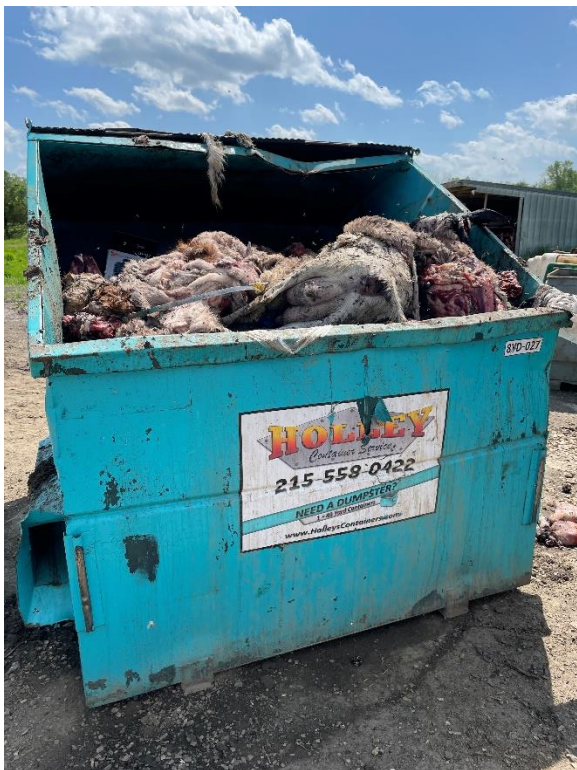
Photo 2 – Dumpster filled with heads and other animal remains
Taken by Jennifer Ramos-Buschmann on 5/8/24, 2:42 PM

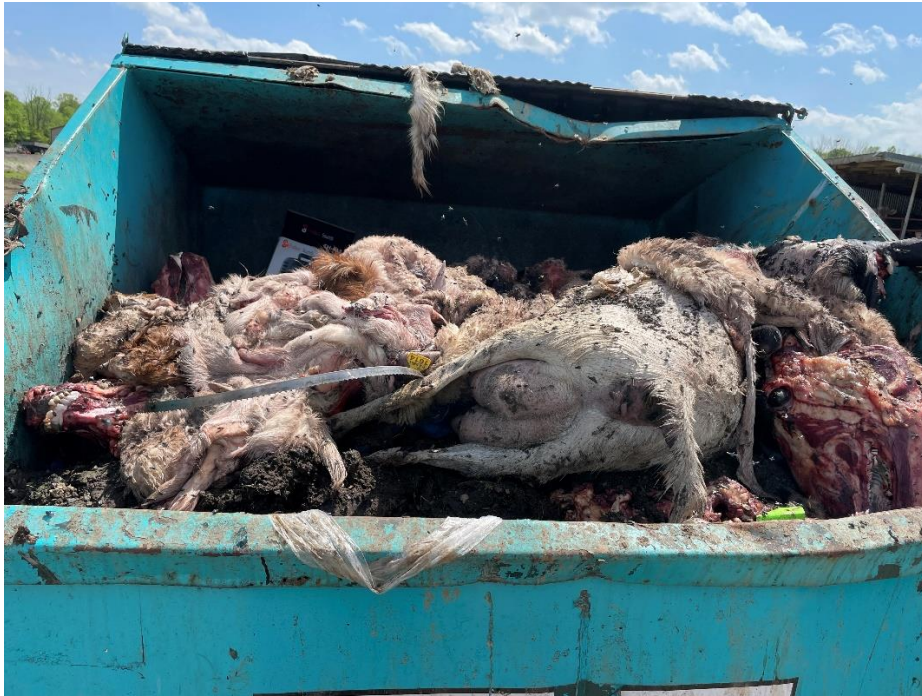
Photo 3 – Close-up of dumpster filled with heads and other animal remains
Taken by Jennifer Ramos-Buschmann on 5/8/24, 2:42 PM

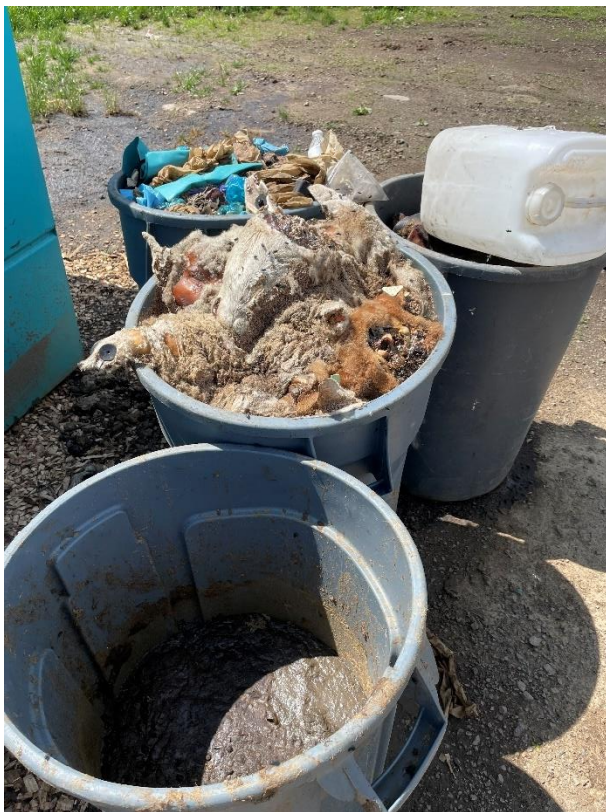
Photo 4 – Trash bins filled with animal remains and trash with numerous flies and maggots
Taken by Jennifer Ramos-Buschmann on 5/8/24, 2:42 PM

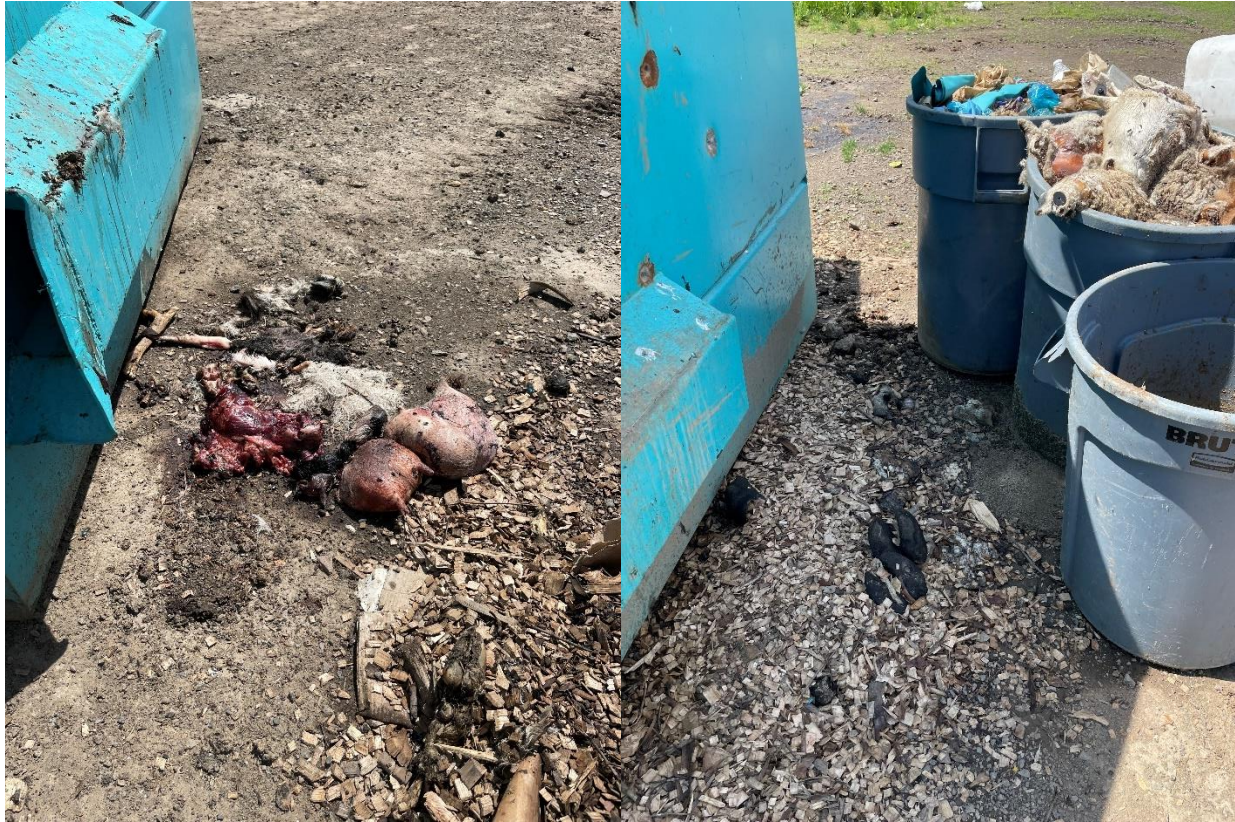
Photos 5 and 6 – Animal remains on ground near dumpsters and trash bins
Taken by Jennifer Ramos-Buschmann on 5/8/24, 2:42 PM and 2:43 PM

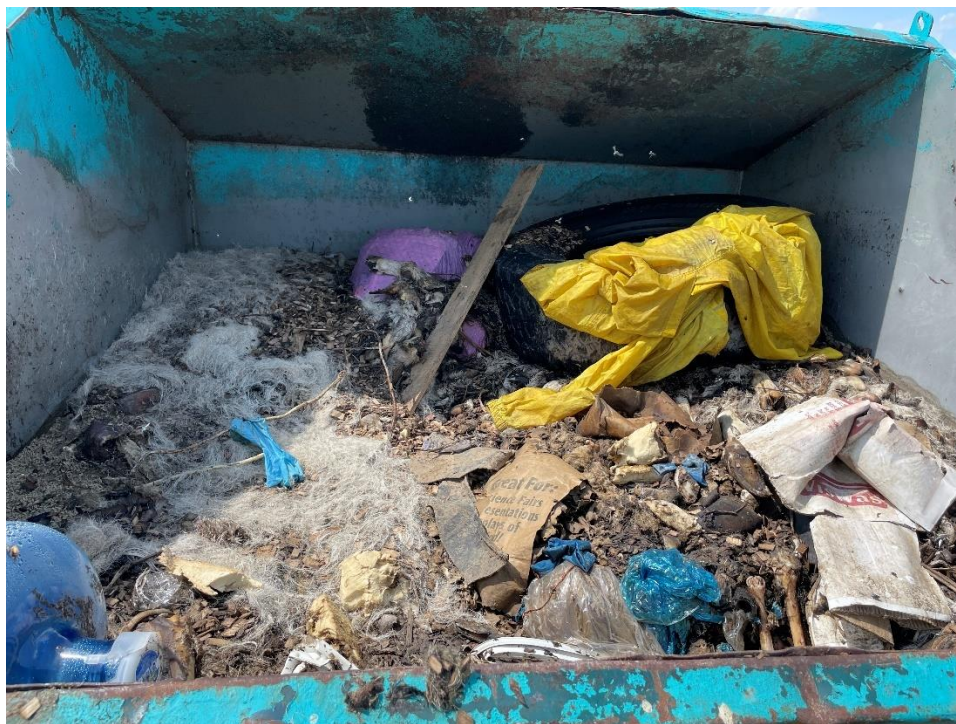
Photo 7 – Second dumpster filled with animal remains, wood chips, and trash
Taken by Jennifer Ramos-Buschmann on 5/8/24, 2:43 PM

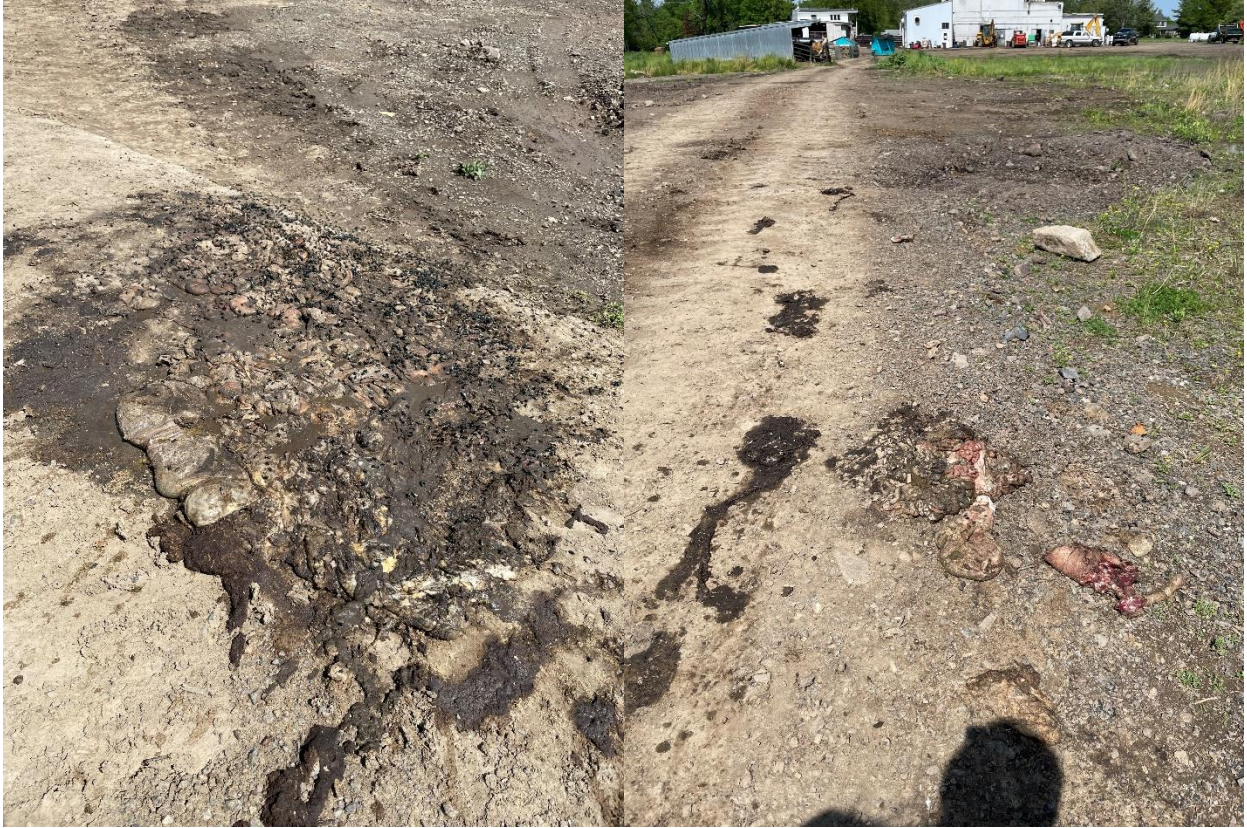
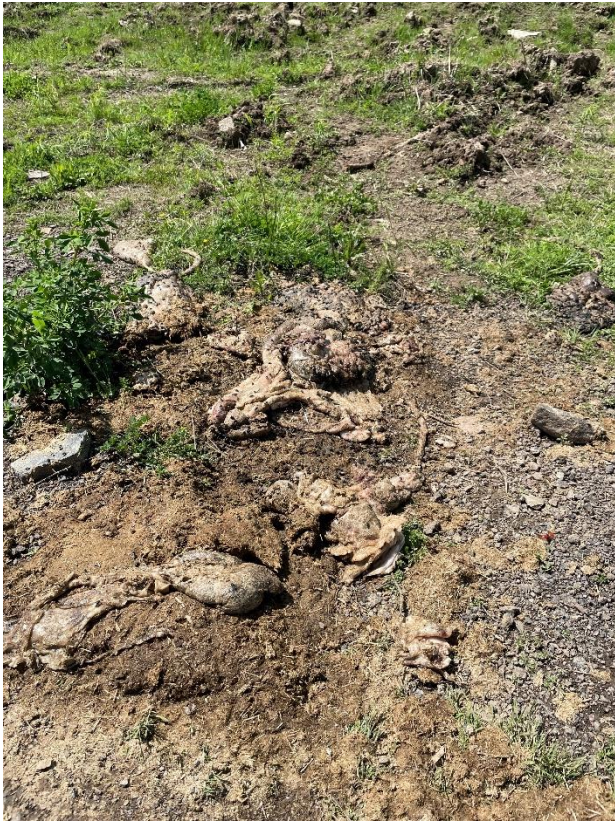
Photos 8, 9, and 10 – Animal remains on ground along pathway to compost pile
Taken by Jennifer Ramos-Buschmann on 5/8/24, 2:43 PM, 2:45 PM, and 2:45 PM

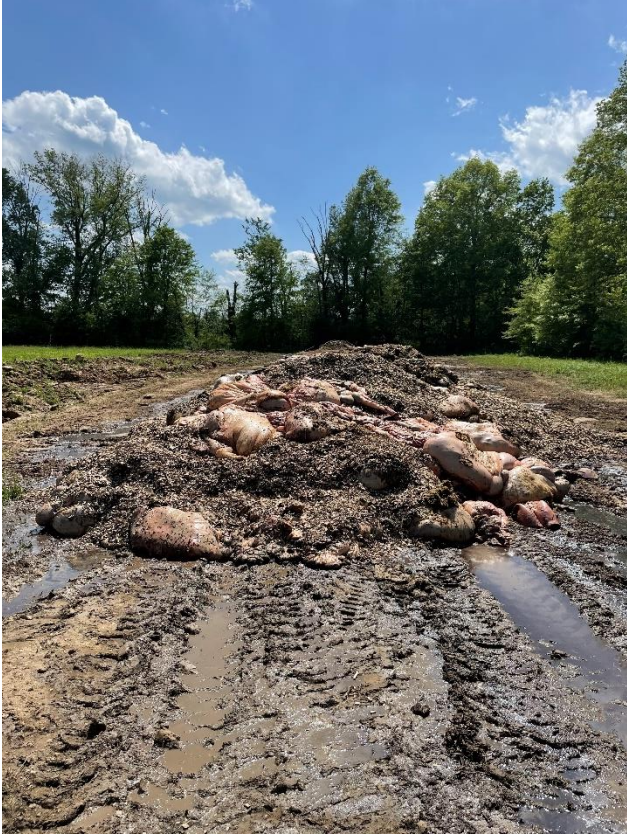
Photo 11 – Uncovered cow stomachs on compost pile
Taken by Jennifer Ramos-Buschmann on 5/8/24, 2:48 PM

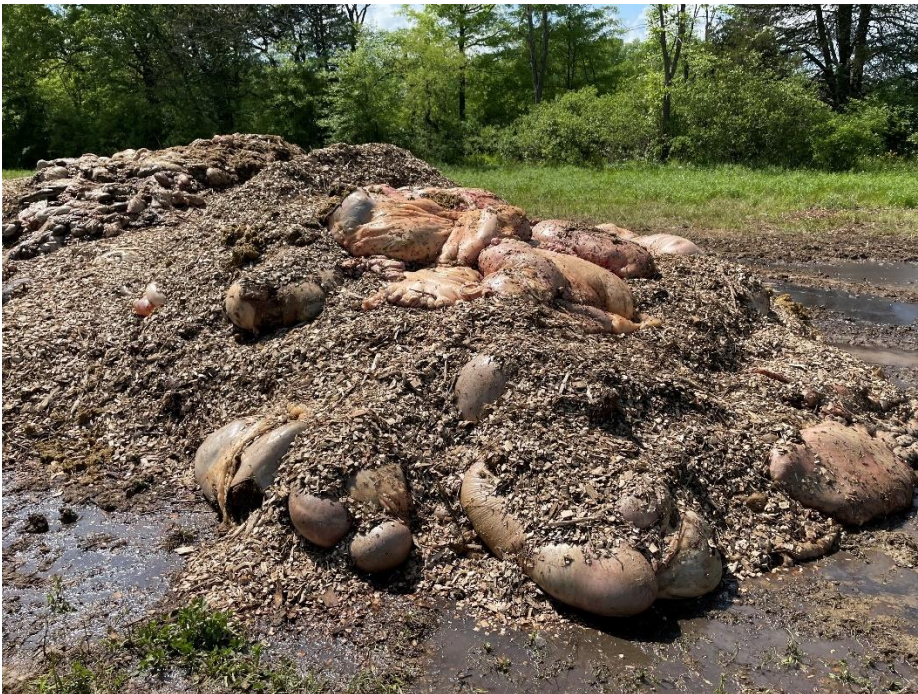
Photo 12 – Close-up of uncovered cow stomachs on compost pile
Taken by Jennifer Ramos-Buschmann on 5/8/24, 2:48 PM

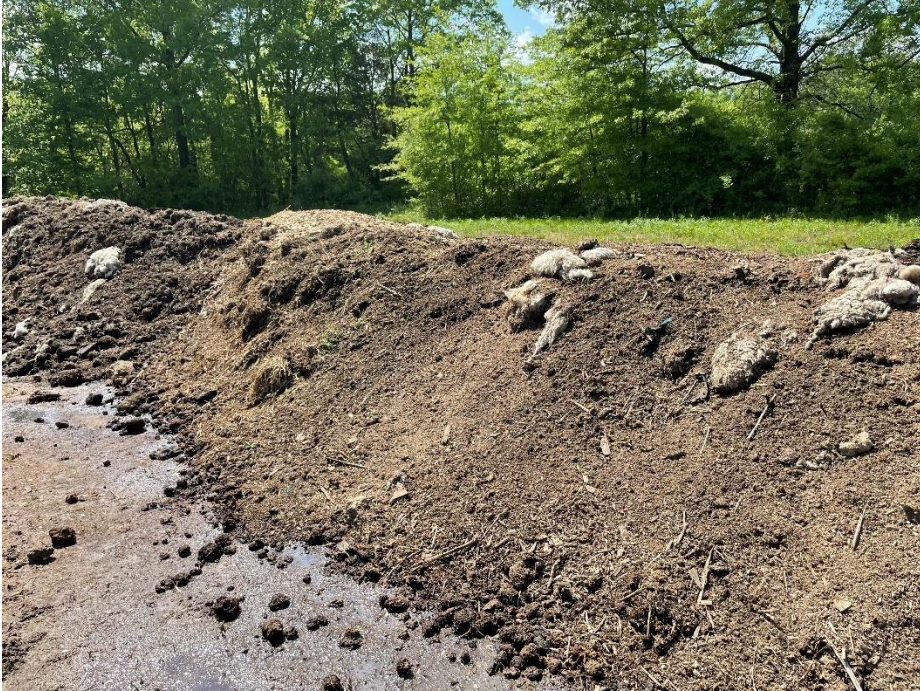
Photo 13 – Mostly covered portion of compost pile
Taken by Jennifer Ramos-Buschmann on 5/8/24, 2:49 PM

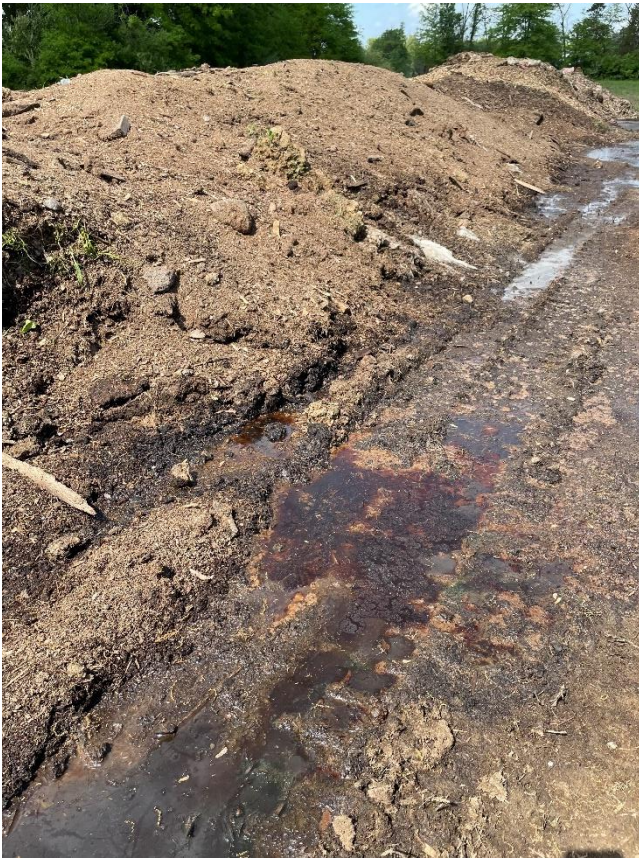
Photo 14 – Pools of blood and water on side of compost pile
Taken by Jennifer Ramos-Buschmann on 5/8/24, 2:50 PM

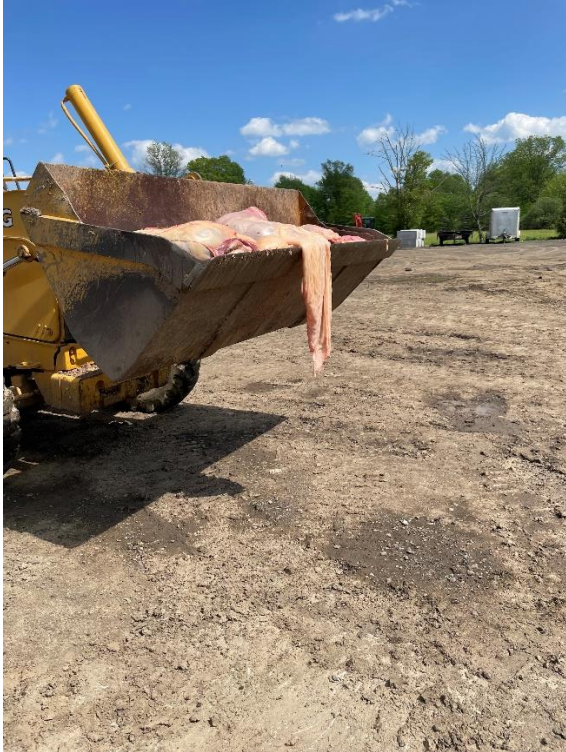
Photo 15 – Front end loader carrying animal remains to compost pile
Taken by Jennifer Ramos-Buschmann on 5/8/24, 2:56 PM

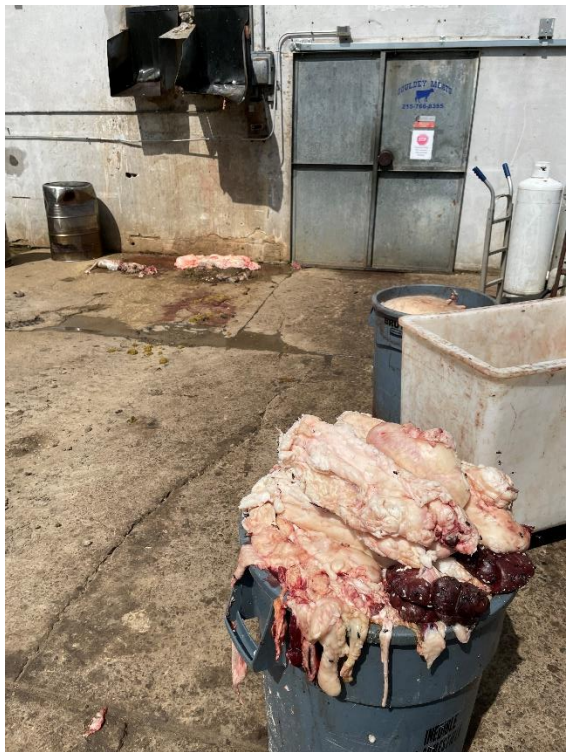
Photo 16 – Trash bin filled with animal remains and animal remains on ground near chutes
Taken by Jennifer Ramos-Buschmann on 5/8/24, 2:56 PM

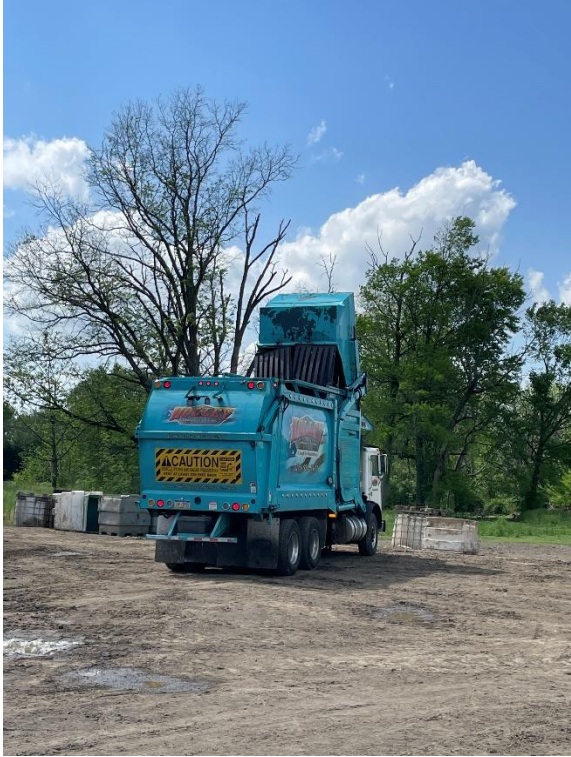
Photo 17 – Holley dump/trash truck picking up the contents of the two dumpsters
Taken by Jennifer Ramos-Buschmann on 5/8/24, 2:58 PM
