Department of Environmental Protection		GENERAL INSPECTION REPORT		Bureau of Land Recycling and Waste Management	
Type of Inspection	WM Identification Number	Entry Time/Date	Inspection ID		
Follow Up Inspection	Site ID: 865337	7/31/2023	3593406		
Facility/Incident Name and Location			Municipality		
Kingdom Provisions			Plumstead		
5960 Durham Road Pipersville PA 18947			County		
			Bucks		
Name, Address of Responsible Official		Title			
Amber Pressley		Manager			
Kerry Rush – Owner Ephriam Stoltzfus – Owner Brent Pressley - Manager		Telephone	Interviewed		
		215-767-8943	Yes <input checked="" type="checkbox"/> No <input type="checkbox"/>

Department of Environmental Protection	GENERAL INSPECTION REPORT	Bureau of Land Recycling and Waste Management
Facility/Incident Name and Location		Municipality
<b>Kingdom Provisions</b>		<b>Plumstead</b>
<b>5960 Durham Road</b> <b>Pipersville PA 18947</b>		County <b>Bucks</b>

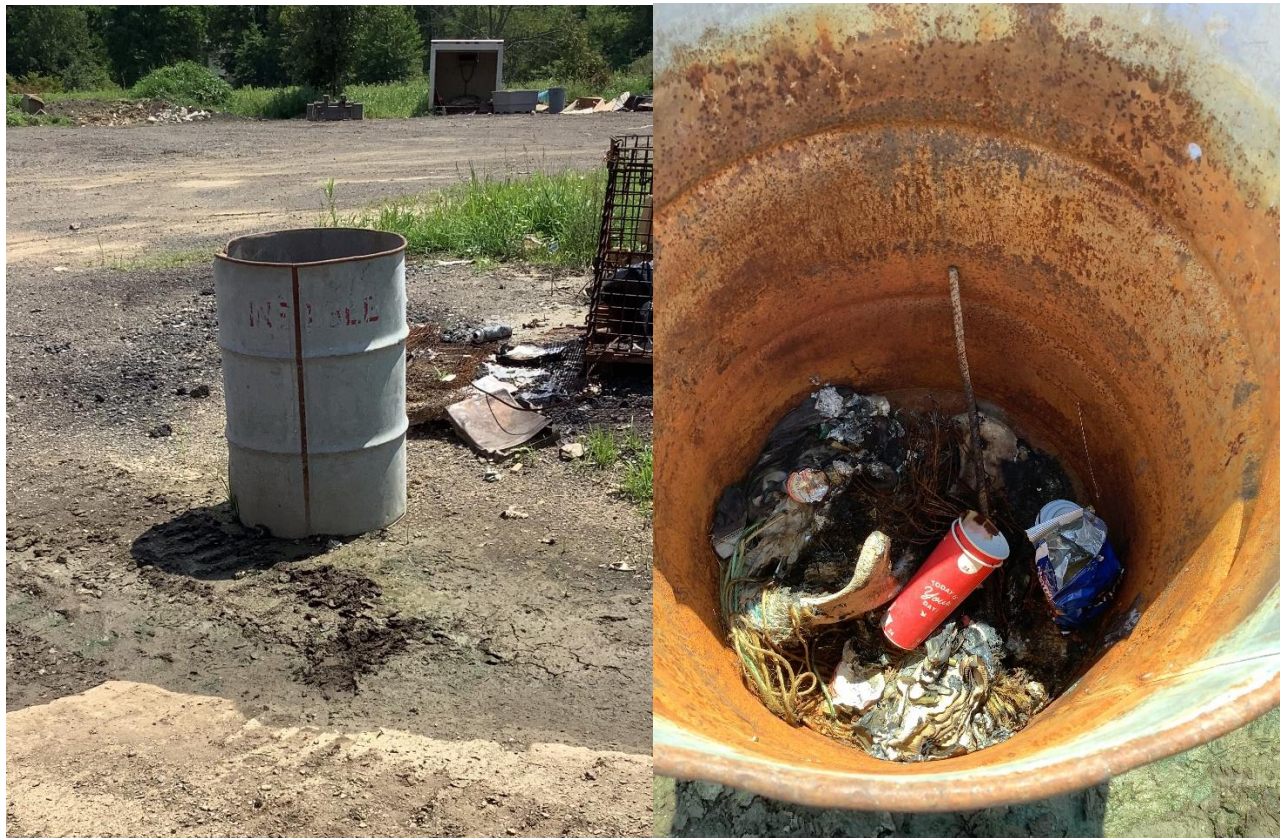
Ms. Pressley was at the site and available to discuss Kingdom Provisions' operations and provide a tour of the facility. A faint odor of decomposing flesh was detectable from the driveway of the Kingdom Provision's property. Ms. Pressley stated that animal remains are currently being added to the compost pile and the facility does not have plans to cease composting operations or remove the material. When questioned about the quantity of livestock being accepted at the facility, Ms. Pressley declined to provide an answer. The facility currently burns the hair off goats, sheep and cow carcasses in a building with exhaust fans. Ms. Pressley stated that Kingdom Provisions has been burning cardboard boxes for a long time and agreed to stop. A drum containing ash residue, solid waste, and part of the carcass of a deceased animal (Image 1) was observed behind the facility next to a cage containing cardboard boxes and other solid waste materials.

Image 1: Burn barrel containing a conglomerate of solid waste and animal remains  
Taken by Molly Goodman on 7/31/2023 at 13:03

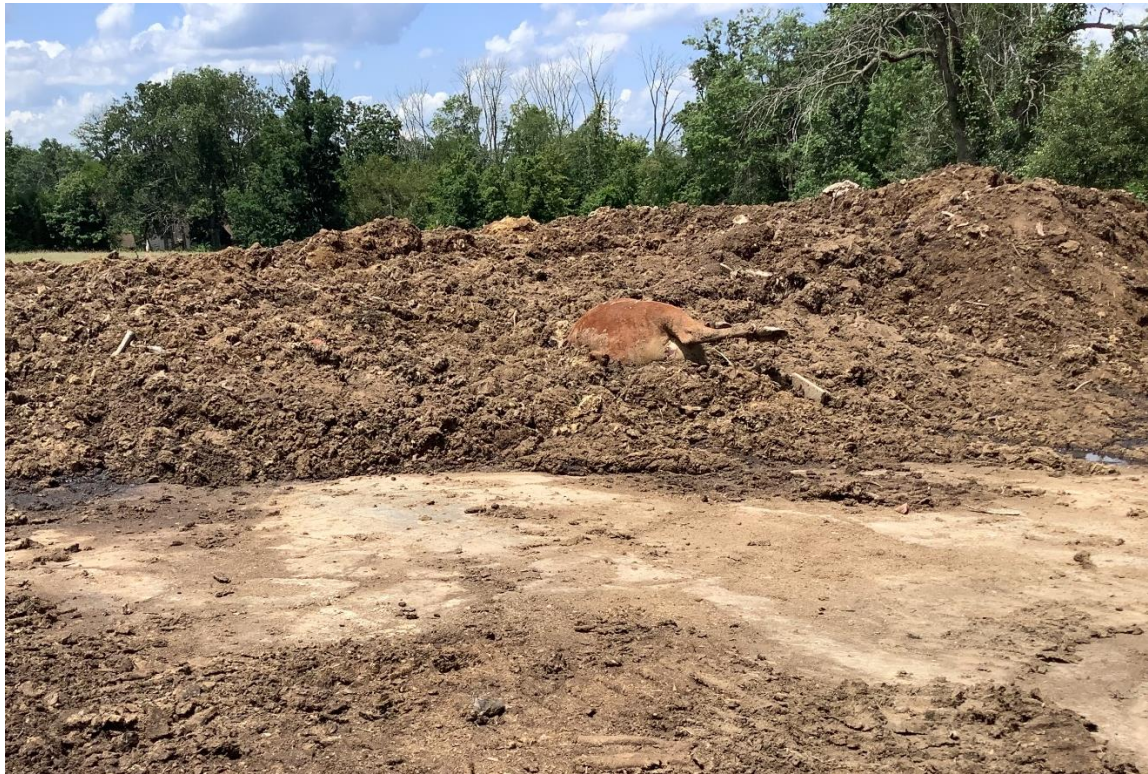
A complete cow carcass was observed on top of the pile of compost (Image 2) and Mr. Pressley stated that when the cow was initially placed, it was covered in a layer of compost, but the carcass bloated due to the heat, causing it to become exposed to the elements. No additional exposed animal waste was observed on the compost pile. Moderate odors of the decomposing animals were detected in the vicinity of the compost pile. The depth or consistency of the compost could not be determined. Standing water was observed around the composting area that appeared dark brown and had many flies surrounding the puddles (Image 3). The standing water appeared to be stormwater that had leached from the compost pile. A berm made of the composting material was near the largest pool and at the time of the inspection, it appeared that the standing water and compost were confined to the cement pad. Ms. Pressley was asked about stormwater management for this area and discussed grading the area to control run-on/run-off.

Image 2: Carcass exposed in compost pile  
Taken by Molly Goodman on 7/31/2023 at 13:05

that the excess material would be added to the compost pile. Ms. Pressley was requested to add adequate cover to the compost area and that putrescible waste should be removed if odors can not be controlled. At the end of the inspection, MOPAC arrived at the site and emptied the containers of acceptable materials.

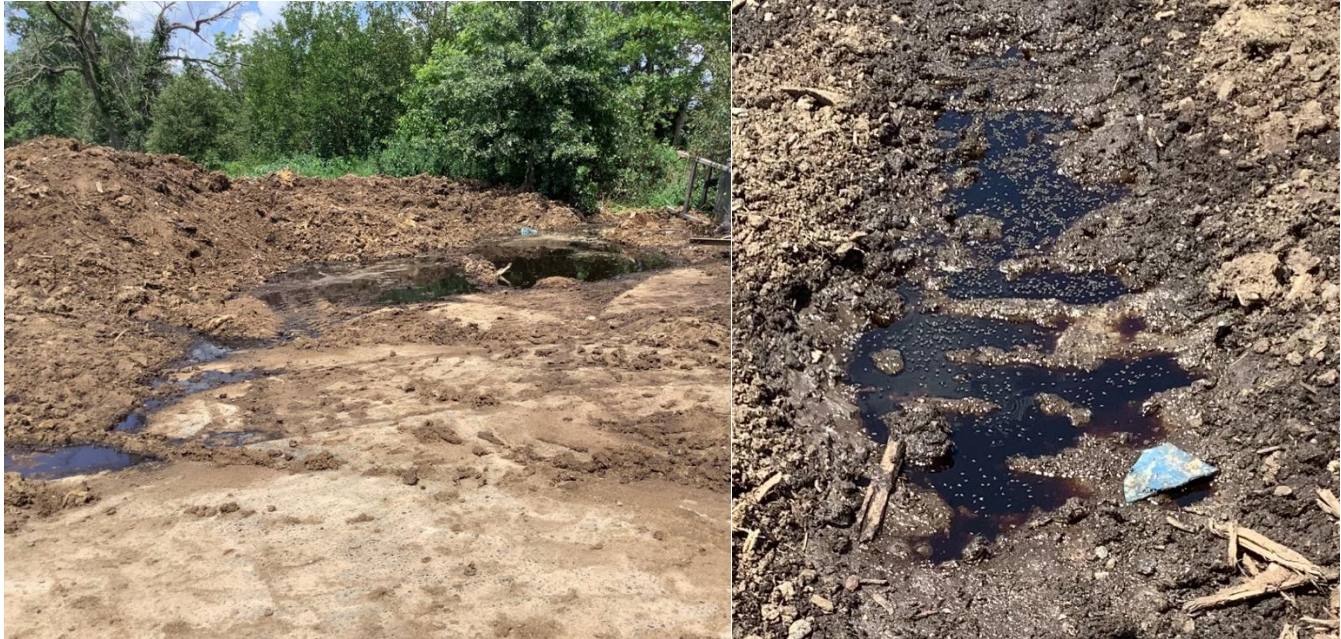
Image 3: Discolored standing water in compost pile  
Taken by Molly Goodman on 7/31/2023 at 13:05

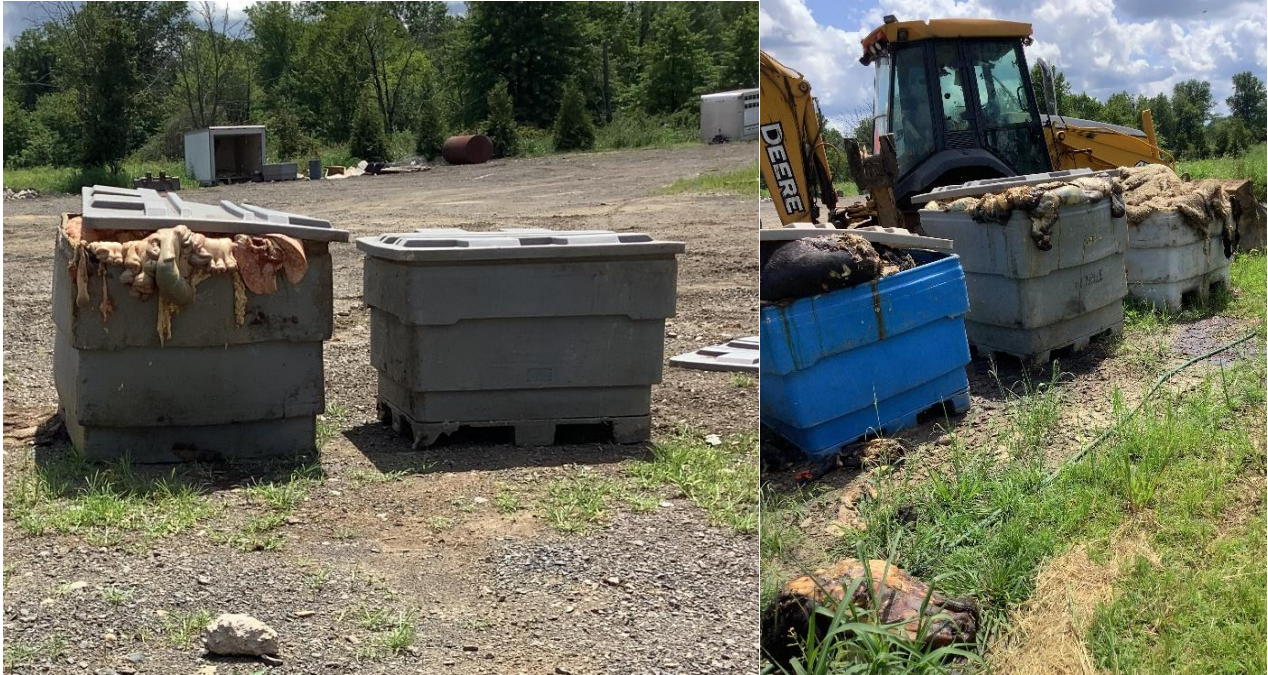
Five (5) containers (Image 4) were observed behind the facility containing the entrails, heads, and hides of slaughtered animals. One (1) container was completely uncovered (Image 5) and was filled beyond capacity. Four (4) had lids that were placed on top of the containers, however, were overfilled so the lids could not properly cover the material. Ms. Pressley stated that a new employee had not punctured the stomachs of the slaughtered cows before placing in the container and the stomachs had expanded in the heat, causing the lids to lift. A backhoe was observed containing the spines and ribs from slaughtered cows (Image 6). A large number of flies and a very strong odor of decomposing animals was observed in this area. Ms. Pressley stated

Image 4: Containers of entrails, heads and skins of slaughtered animals  
Taken by Molly Goodman on 7/31/2023 at 12:50

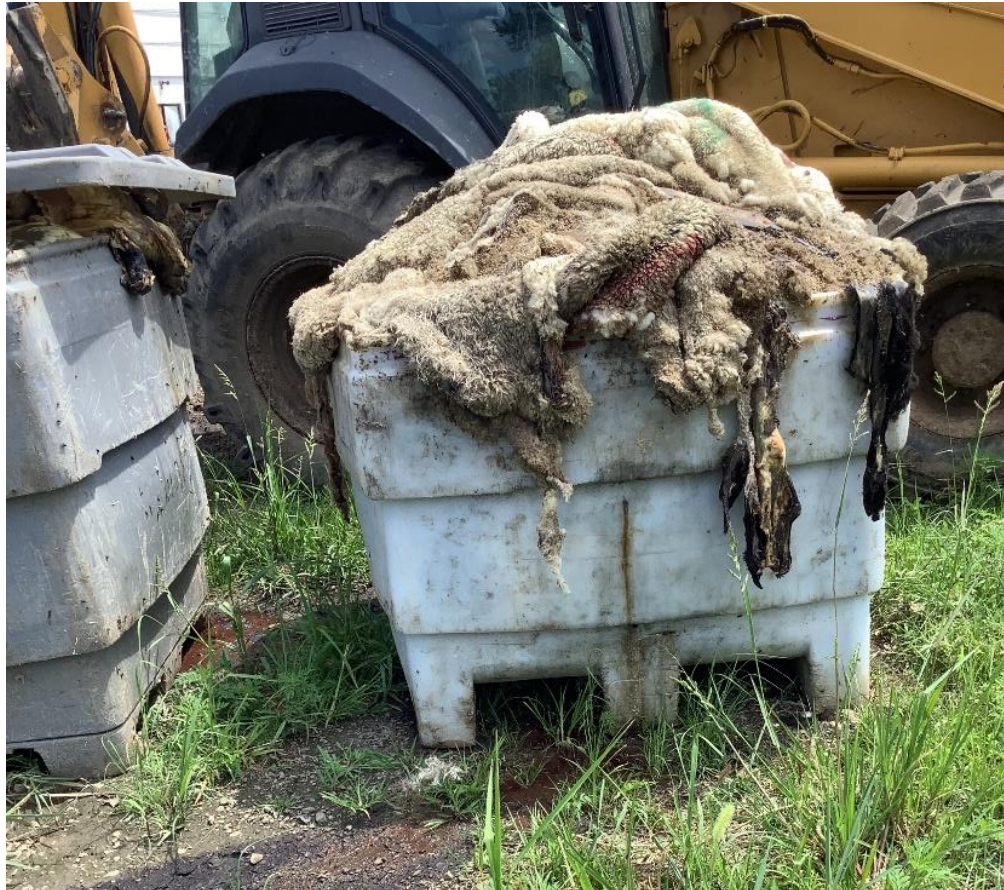
Image 5: Overflowing, uncovered container of animal skins  
Taken by Molly Goodman on 7/31/2023 at 12:52

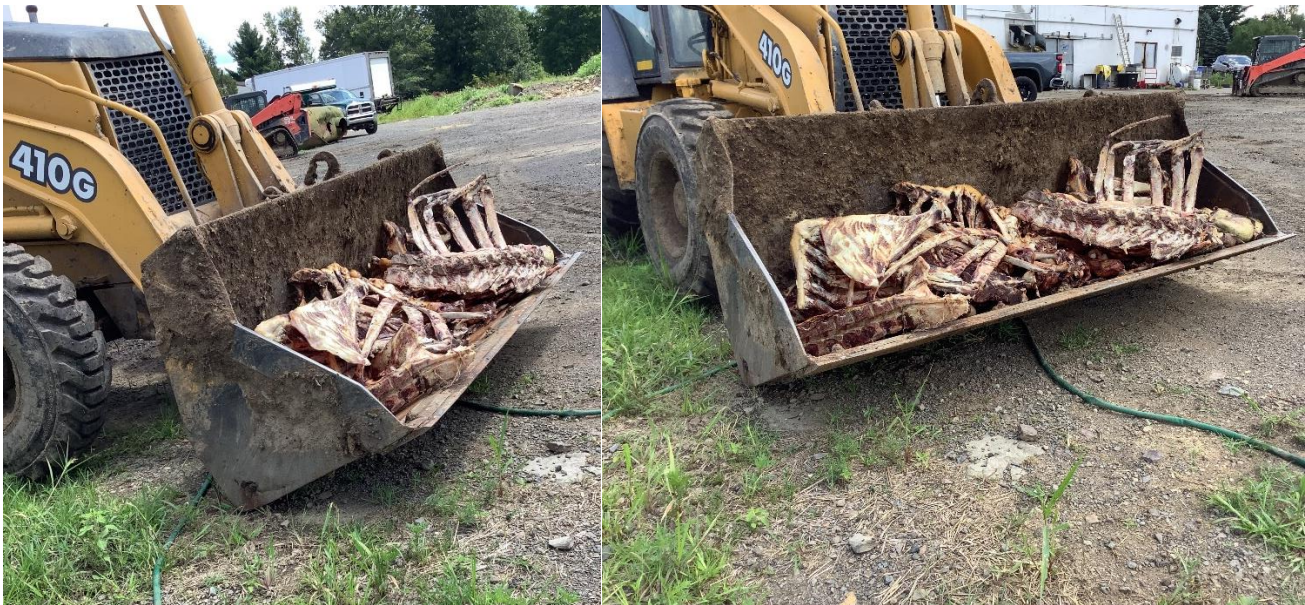
Image 6: Cow backbones stored in bucket of backhoe  
Taken by Molly Goodman on 7/31/2023 at 12:59
