Department of Environmental Protection	GENERAL INSPECTION REPORT	Bureau of Land Recycling and Waste Management
---	------------------------------	--

Type of Inspection <b>Complaint Inspection</b>	WM Identification Number <b>Site ID: 865337</b>	Entry Time/Date <b>7/6/2023</b>	Inspection ID <b>3581198</b>
Facility/Incident Name and Location <b>Kingdom Provisions</b>			Municipality <b>Plumstead</b>
5960 Durham Road Pipersville, PA 18947			County <b>Bucks</b>
Name, Address of Responsible Official <b>Ephriam Stoltzfus Brent Pressley</b>		Title <b>Owners/Operators</b>	
5960 Durham Road Pipersville, PA 18947		Telephone <b>215-767-8943</b>	Interviewed Yes <input checked="" type="checkbox"/> No <input type="checkbox"/>

On July 6, 2023, I, Molly Goodman – Solid Waste Specialist, conducted an inspection of Kingdom Provisions, located at 5960 Durham Road, Pipersville, PA 18947. The inspection was in conjunction with Jennifer Ramos-Buschmann, Air Quality Specialist, and William Laufer, Environmental Trainee, from the Department's Air Quality Program and was initiated in response to complaints regarding foul odors originating at the site.

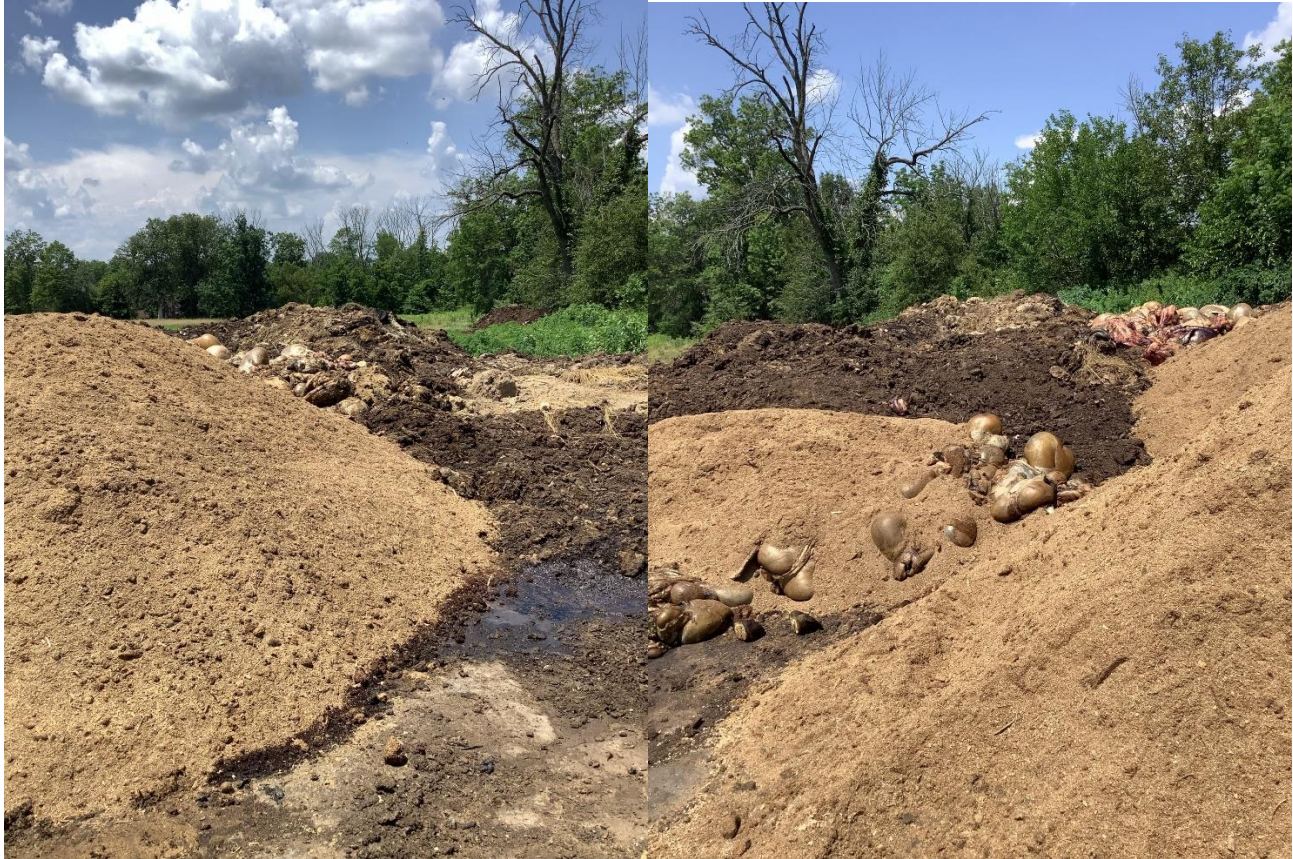
The composting area (Image 1) contained a layer of exposed animal entrails and Mrs. Pressley stated that the compost is turned and covered. The facility was reminded to immediately cover the material after adding to the pile. A container and cardboard box (Image 2) were observed adjacent to the compost pile and contained open plastic bags of what appeared to be old meat. A large quantity of vectors was observed, and the facility was reminded to properly containerize food processing residual wastes. An additional container (Image 3) was observed to have a dark sludge from the decomposition of skins and bones. Mrs. Pressley stated

Image 1: Compost pile with exposed animal entrails  
 Taken by Molly Goodman on 7/6/2023

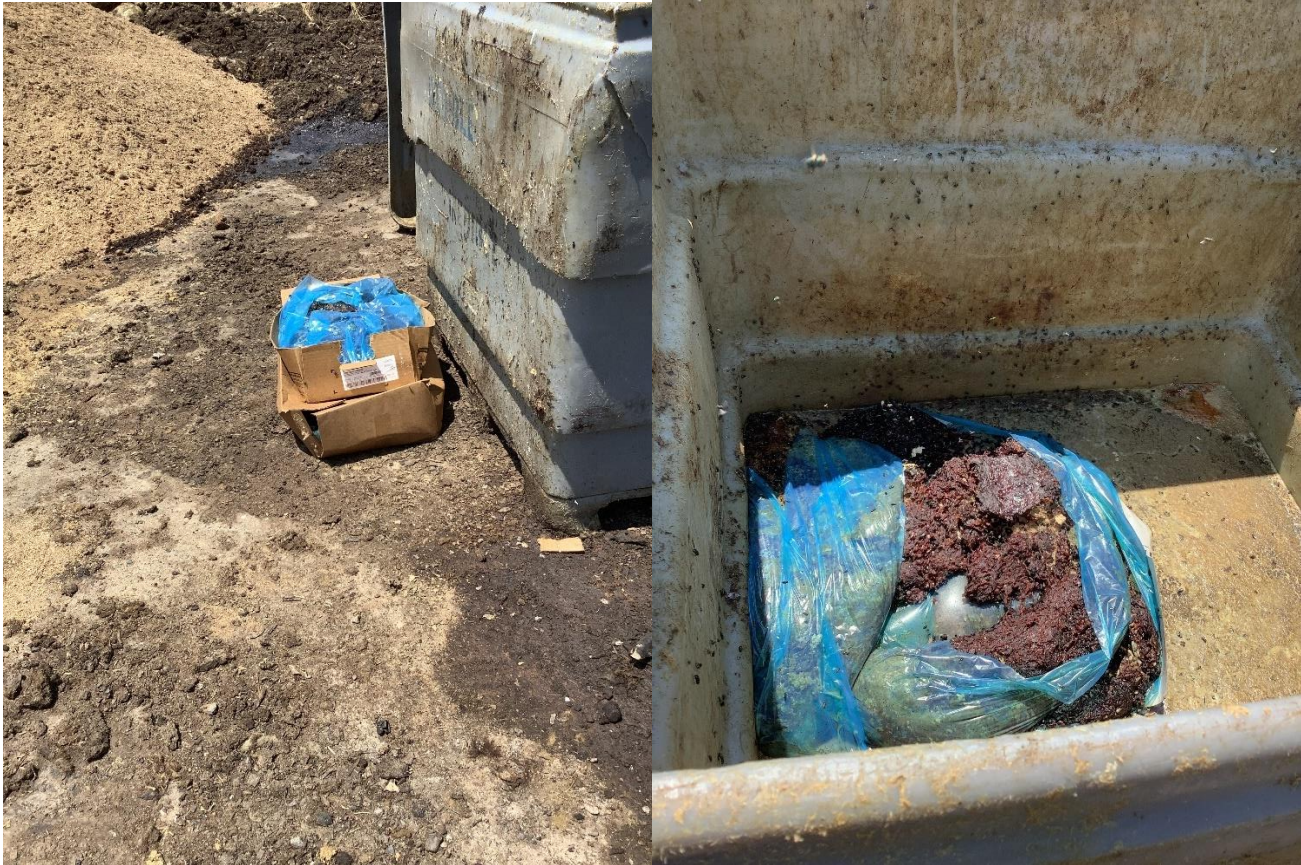
Image 2: Open bags of remains adjacent to compost pile  
Taken by Molly Goodman on 7/6/2023

that she would remove the material immediately and request new, clean containers from Darling Rendering. Mrs. Pressley stated that she will send the Department a copy of a receipt or other evidence that the material has been removed from the site.

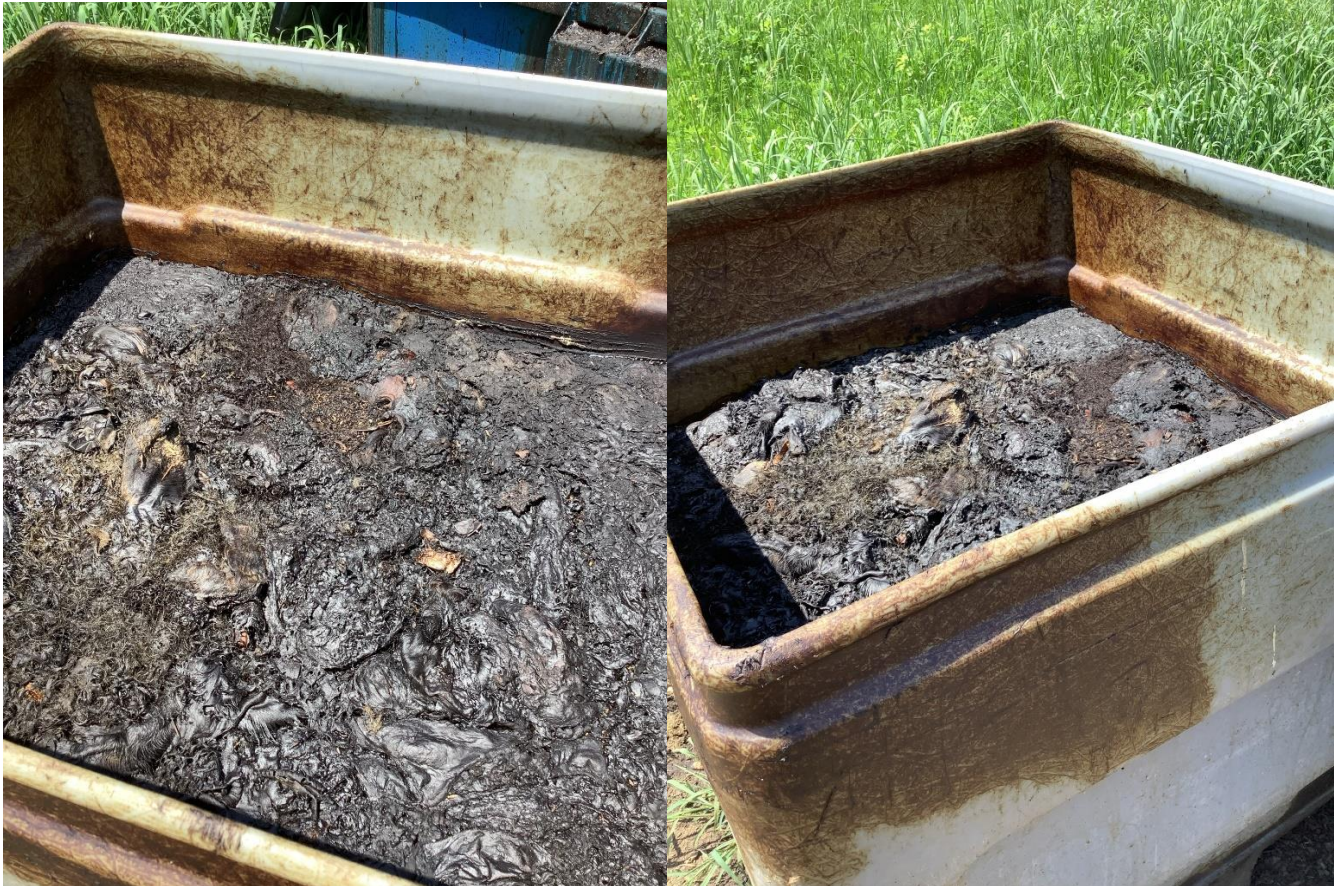
Image 3: Container with decomposing remains  
Taken by Molly Goodman on 7/6/2023

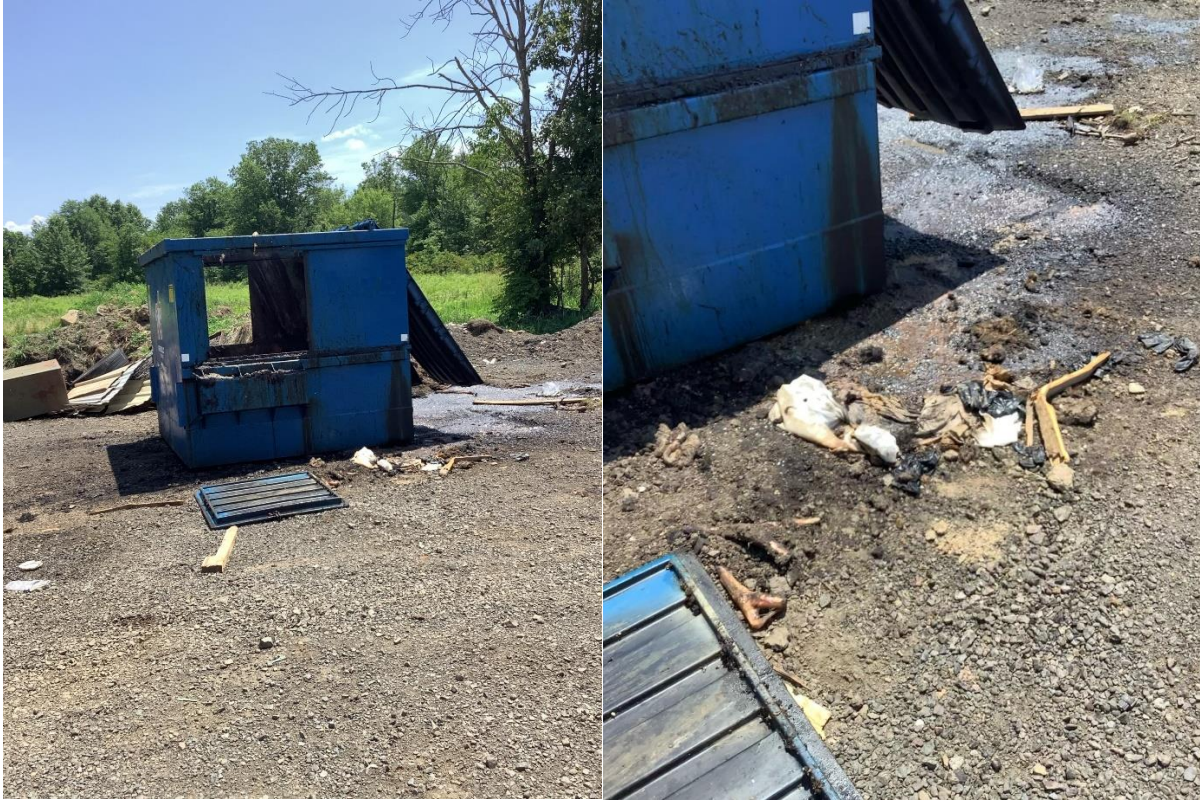
The dumpster at the site (Image 4) was observed to be approximately half-way full of a conglomerate of skin, bones, and non-animal biproducts of the residual waste operation (Image 5). The dumpster appeared to be leaking fluids and the facility was actively covering the affected areas of the ground. The facility was reminded to properly containerize waste materials in a manner that prevents leaks or other releases. Additionally, the facility was requested to submit to the Department a copy of a disposal receipt.

Image 4: Container with fluids leaking onto gravel  
Taken by Molly Goodman on 7/6/2023

**Kingdom Provisions should respond within 10 days of receipt of this inspection report with documentation in the form of a disposal receipt demonstrating the proper disposal of the putrescible waste in the containers. Furthermore, Kingdom Provisions should provide a plan describing future waste handling from the slaughtering operation as well as BMPs to be implemented to address the composting and application of the waste.**

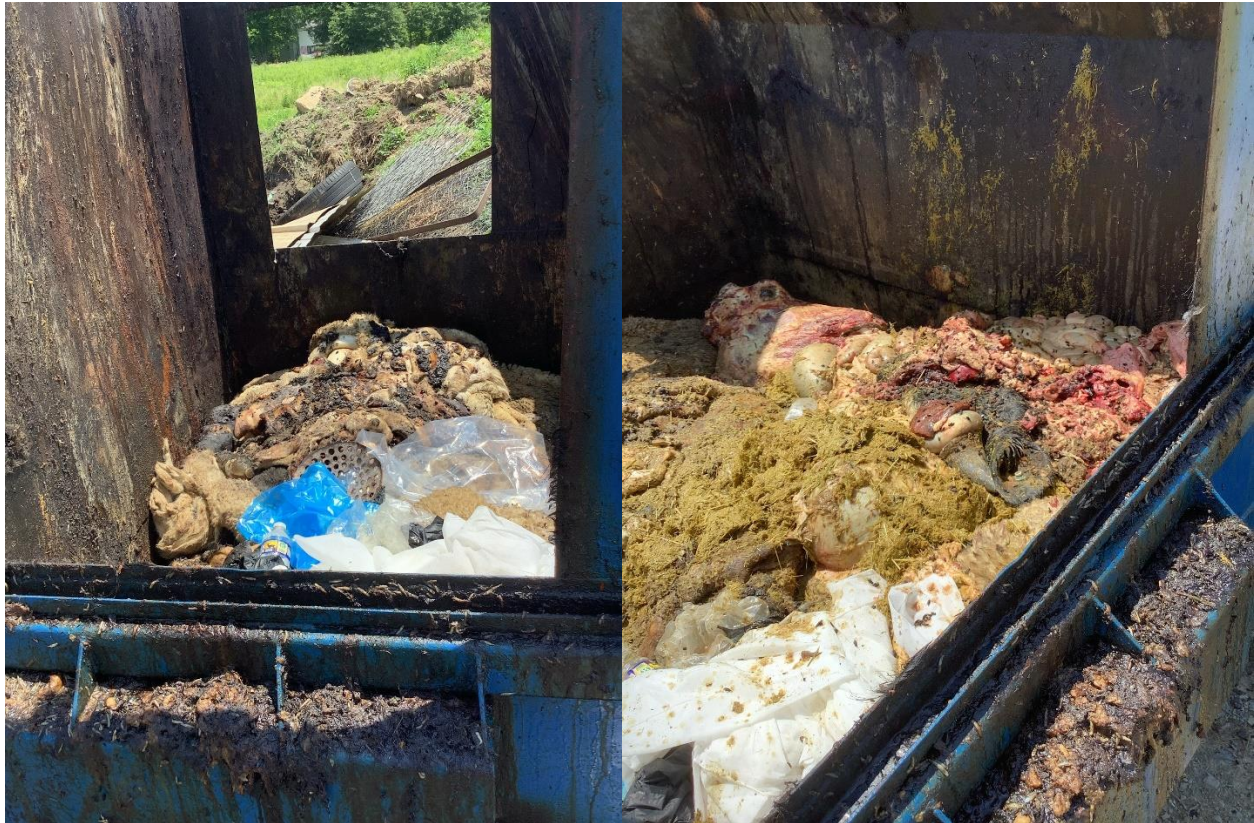
Image 5: Contents of dumpster onsite  
Taken by Molly Goodman on 7/6/2023
